# Peabody Coal – InstaTurf ShearForce10 ECTRM Trial Channel Installation

ShearForce10 ECTRM Installed over cool season grass mix in high flow channel at the base of an overburden cap on September 10, 2019. Objective: Evaluate potential as rock riprap replacement in high flow areas at the mine

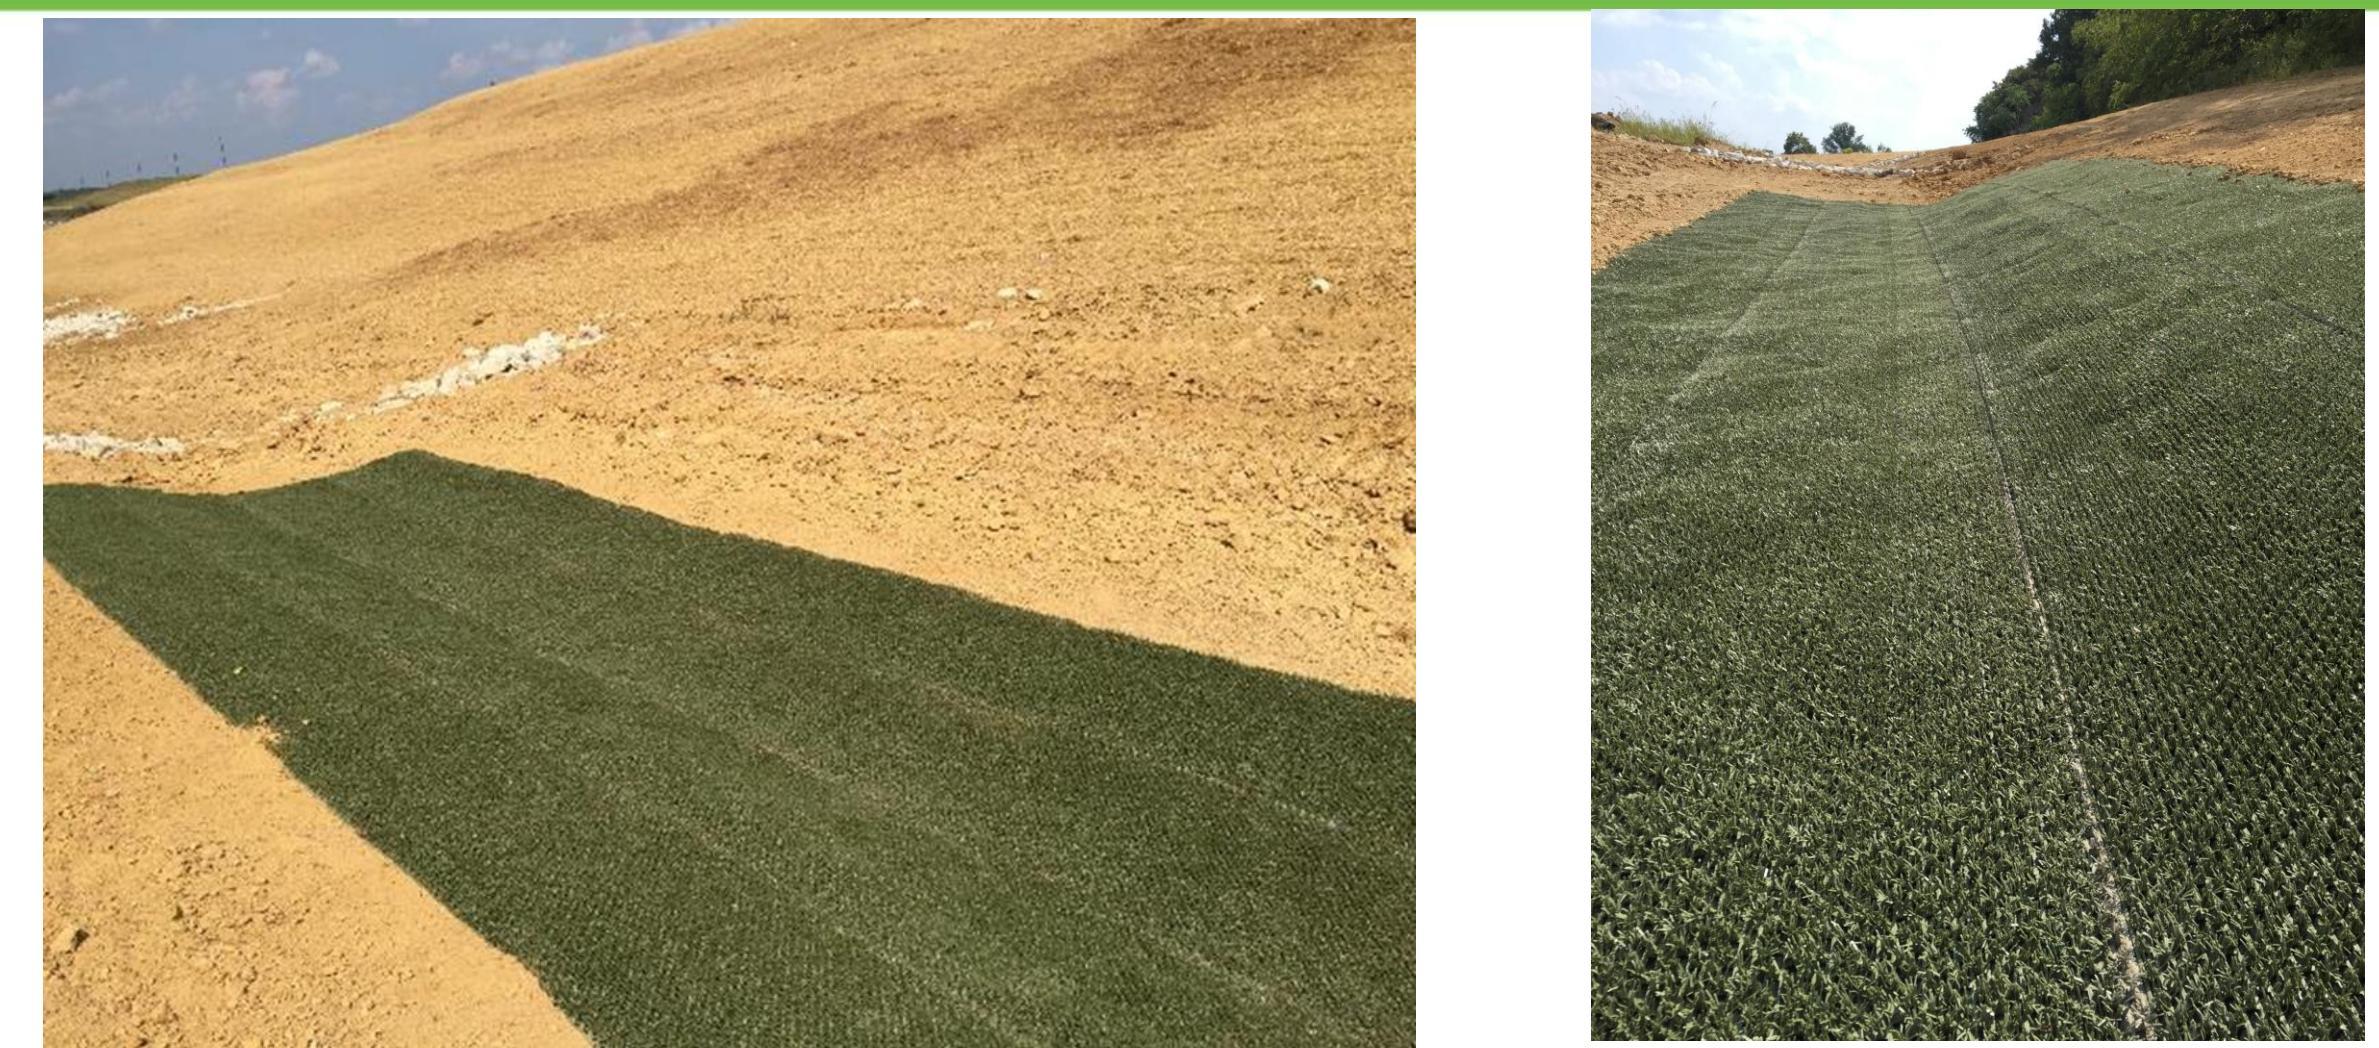
### InstaTurf ShearForce10 Anchoring

Mats were installed between rock checks using 8 inch sod staples and 6 inch fabric pins on 1.5 ft centers according to published InstaTurf installation guidelines. Note small sections of channel downstream and upstream of mats left unprotected for comparison.

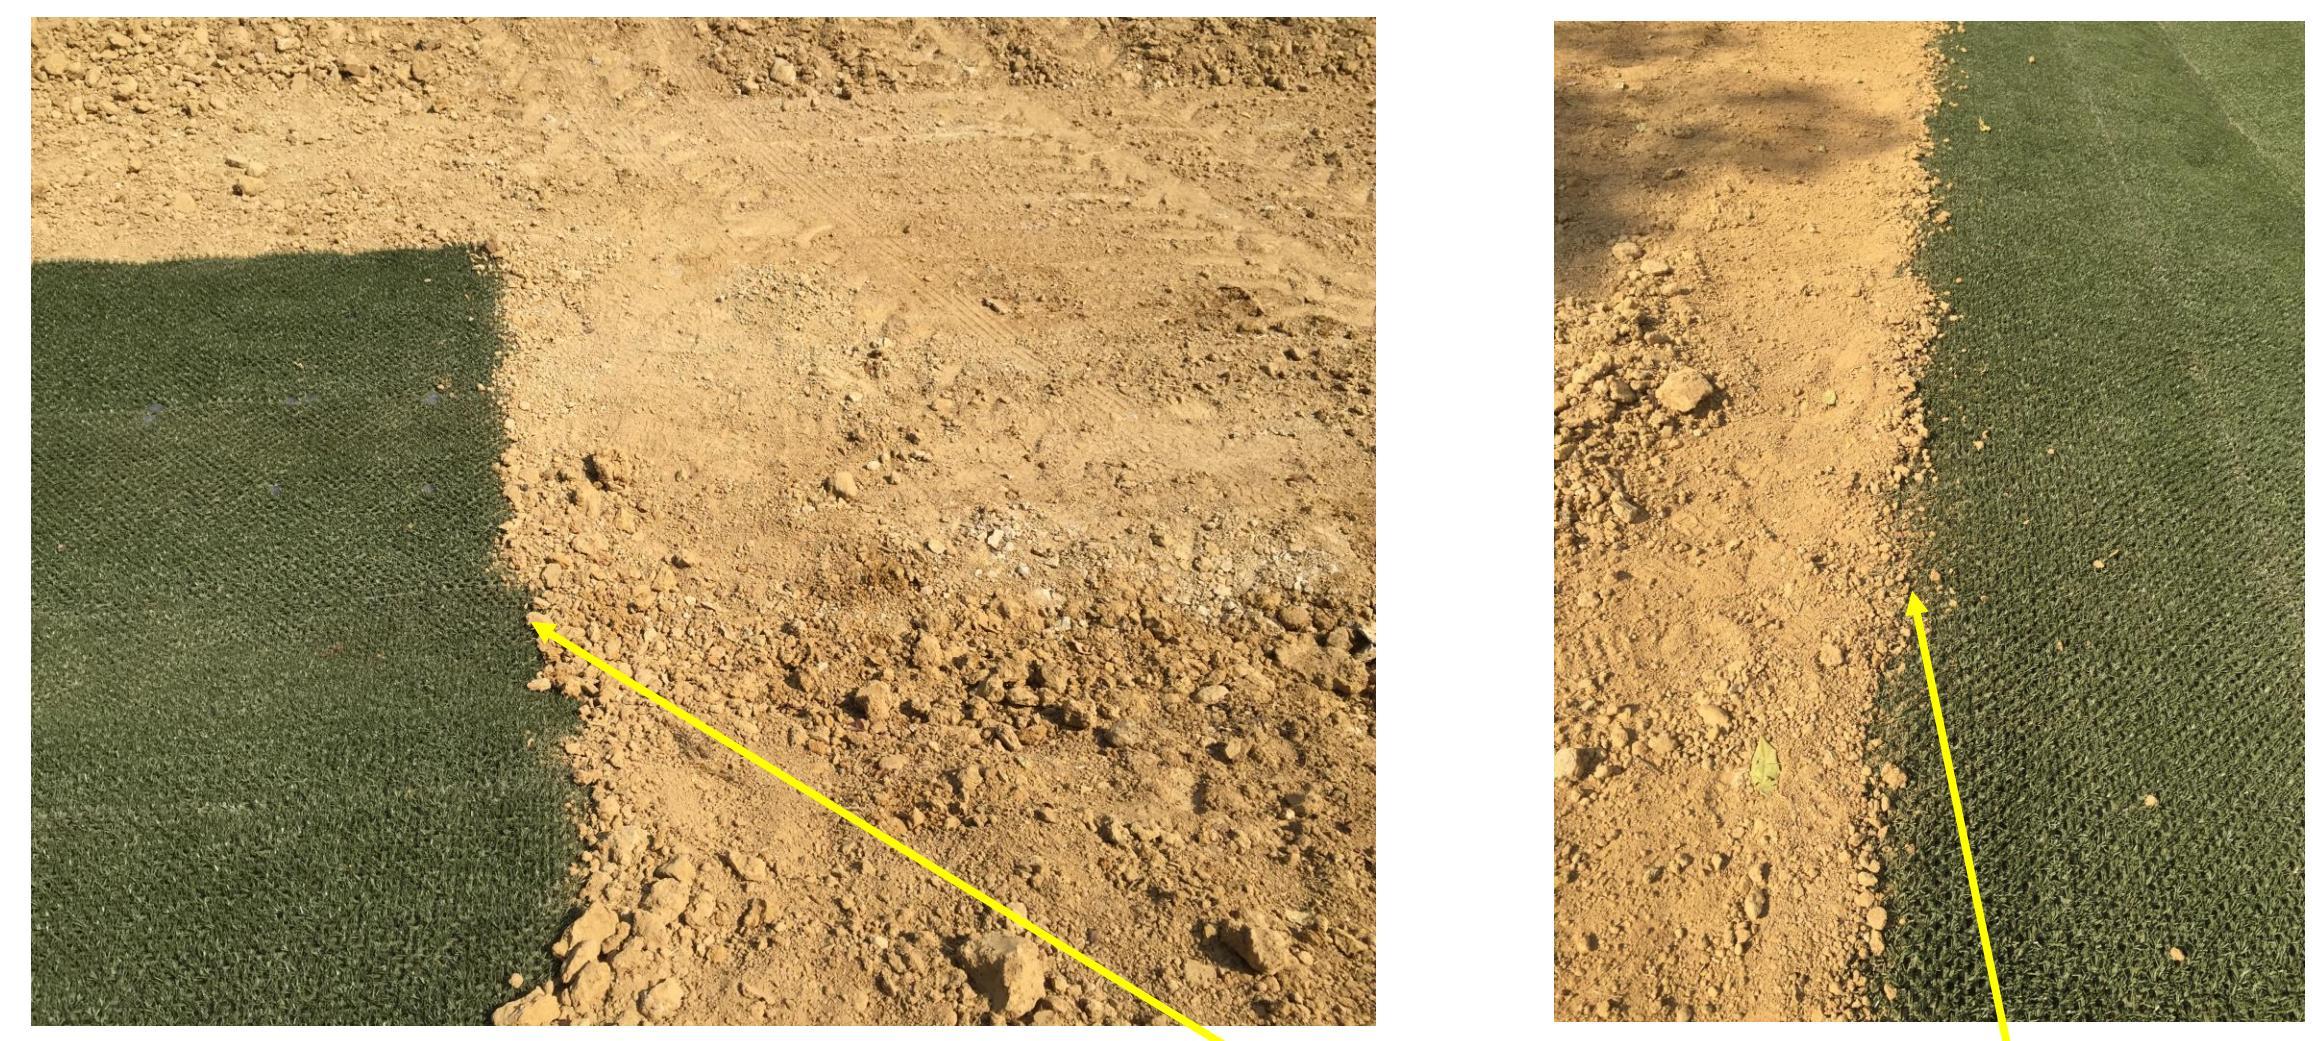
Upslope terminal ends of mats were trenched in approximately 6 inches (left). Mat edges at top of both sideslopes (Right photo) and downstream terminal ends were simply stapled on 9 inch centers with loose soil placed over edges.

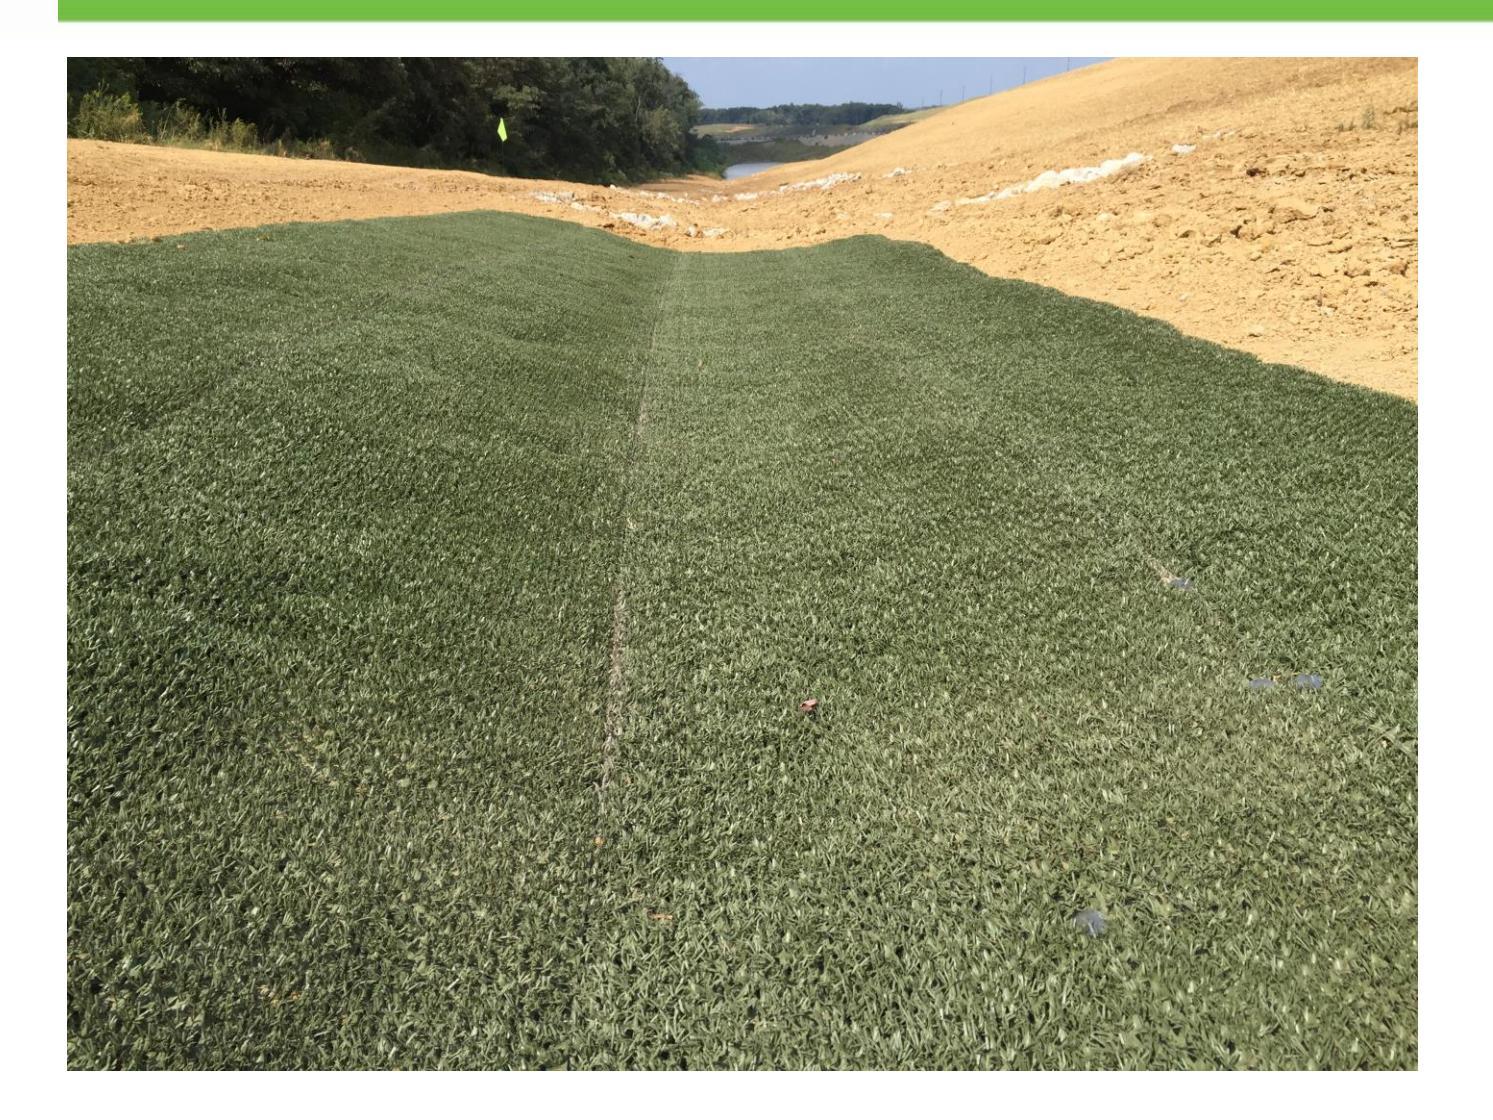
Completed ShearForce10 Installation looking down channel grade

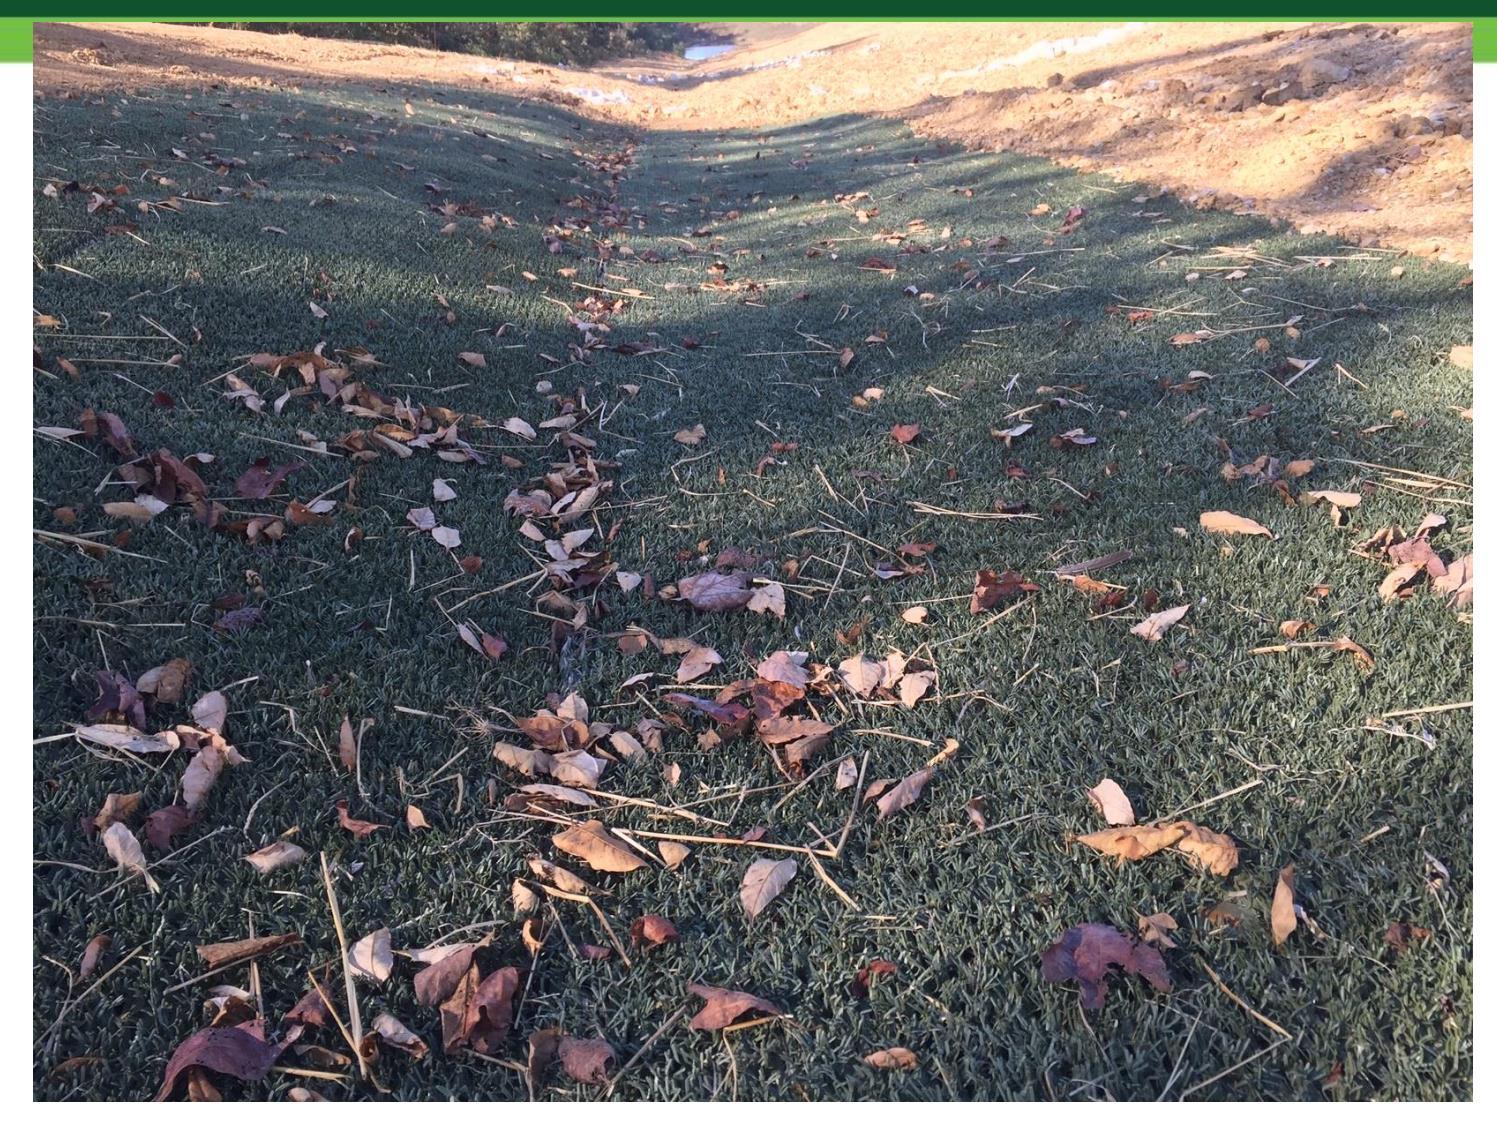
### Nearly One Month Later, ShearForce10 Waiting for Rain

Due to the lack of rainfall in September (.6 inch total), very little germination had occurred by Oct 7

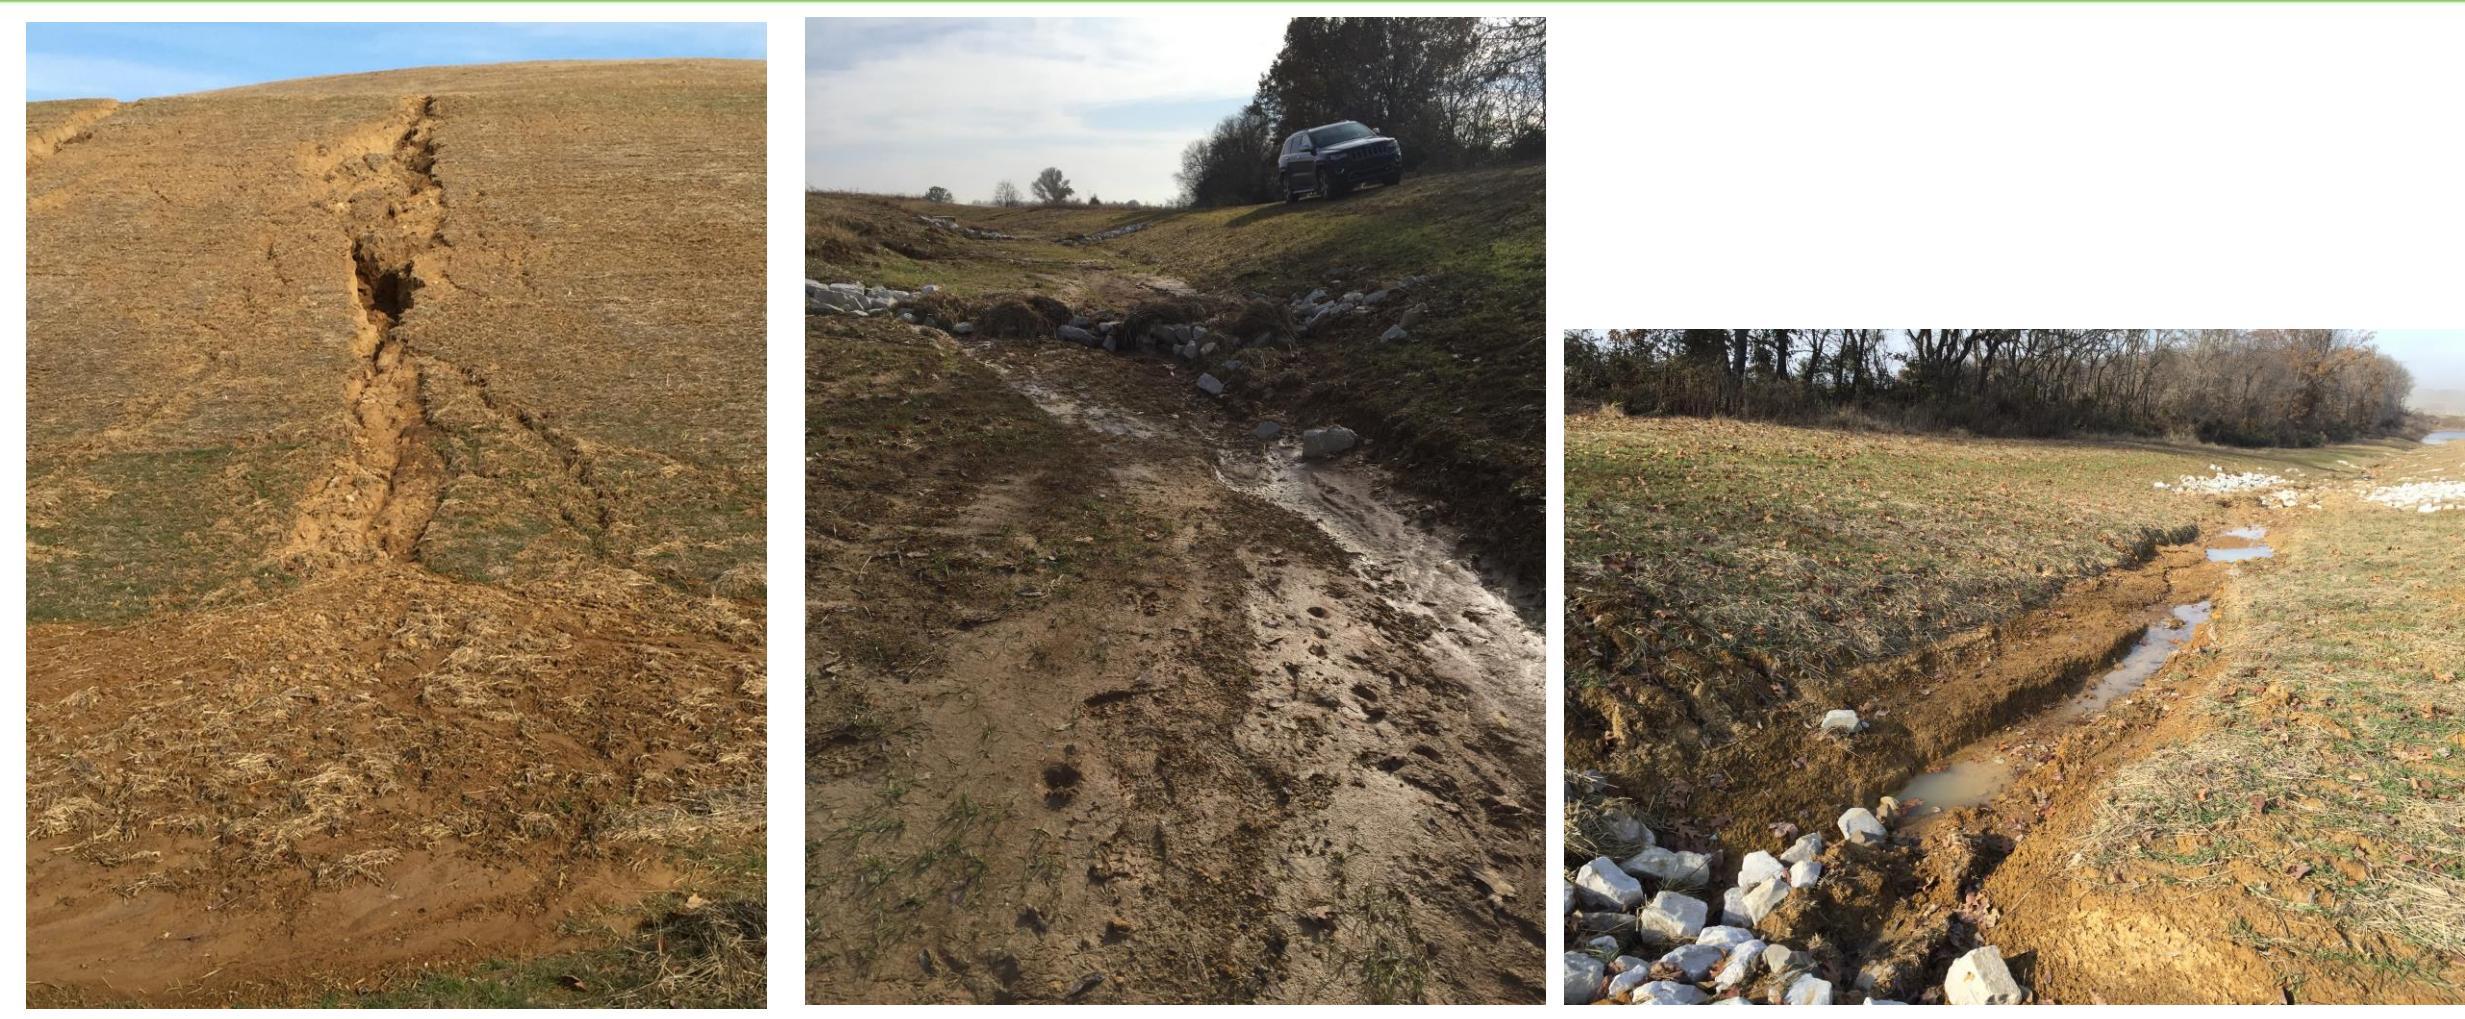
### Major Erosion Damage of Unprotected Areas Caused by Late October Storm Flows

...Just two weeks later, the rains came, with major storm events on Oct 21 (1.65 in) and Oct 26 (2.2 in) wreaking havoc on straw mulched slopes/channel bottom and riprap check dams as apparent in these photos taken Nov 20. Over 6.5 inches of rain fell in October, what a mess!

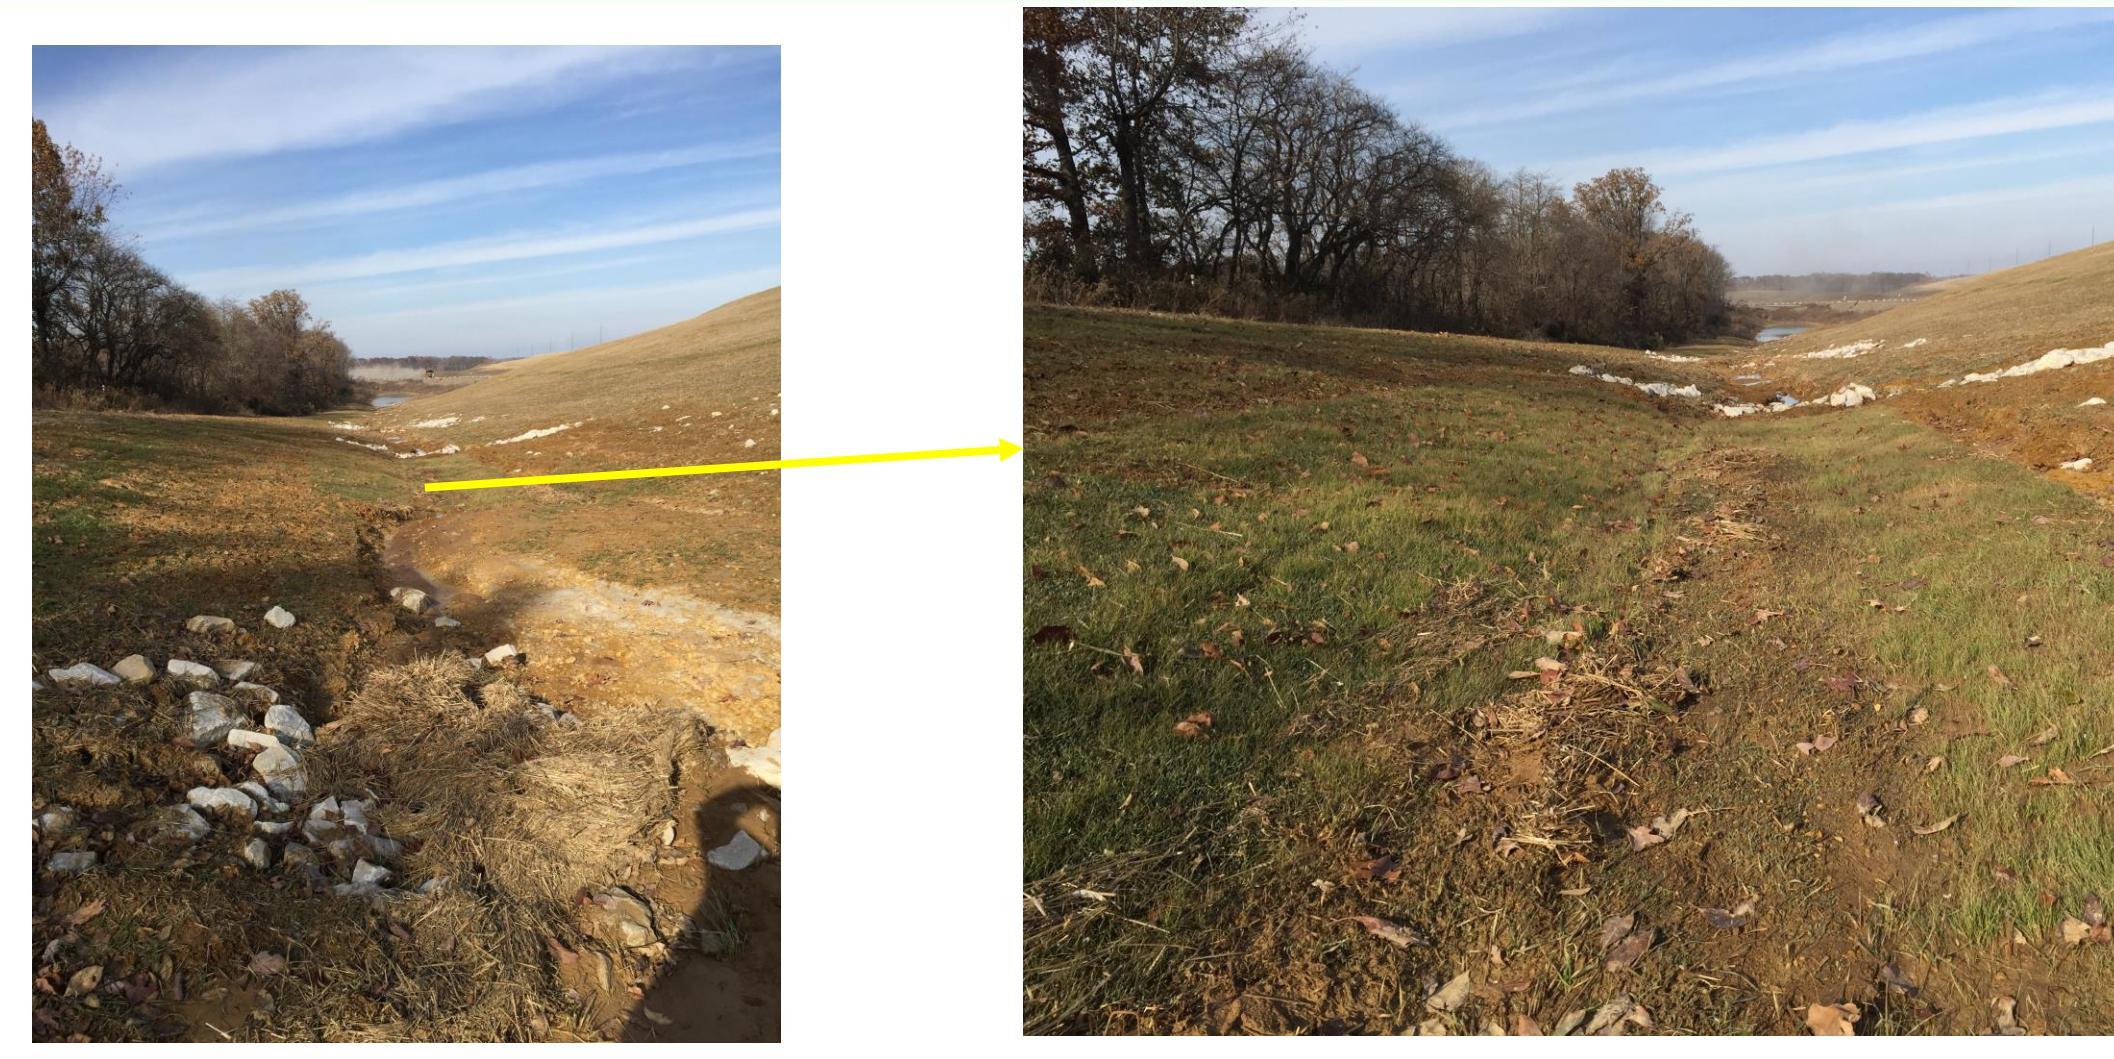
### ShearForce10 Protected Section Locked Down Solid!

But wait, what's that green patch between those ugly rock piles? ShearForce10 had survived the multiple deluges with no significant erosion issues. Note new vegetation growth and sediment deposition on top of mats.

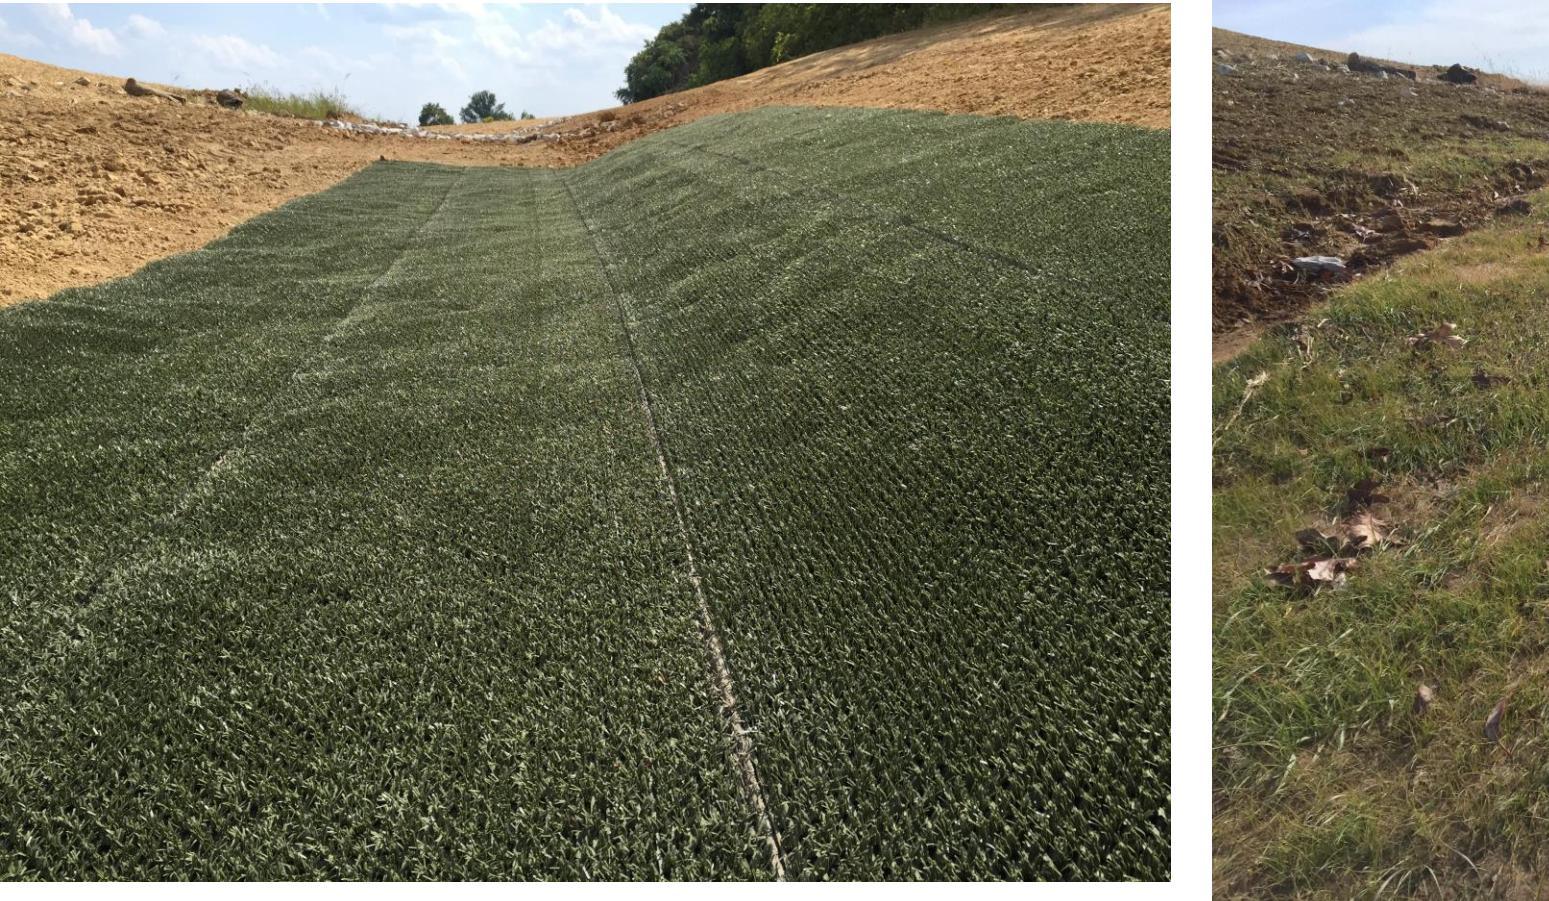
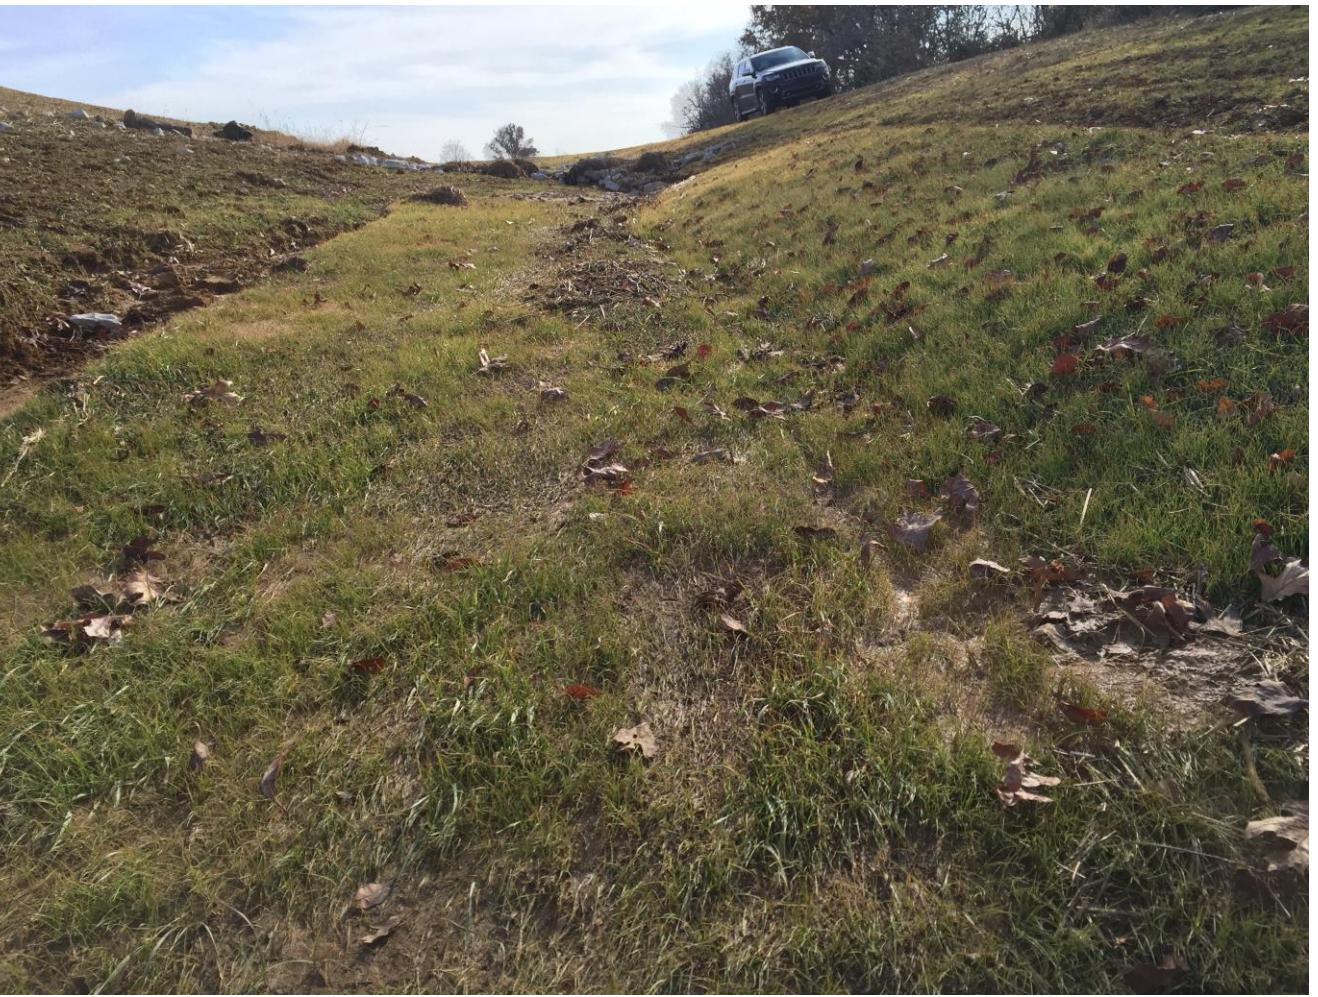
Upslope view of ShearForce10 just after installation on Sep 10 (left) and on Nov 20 (right).

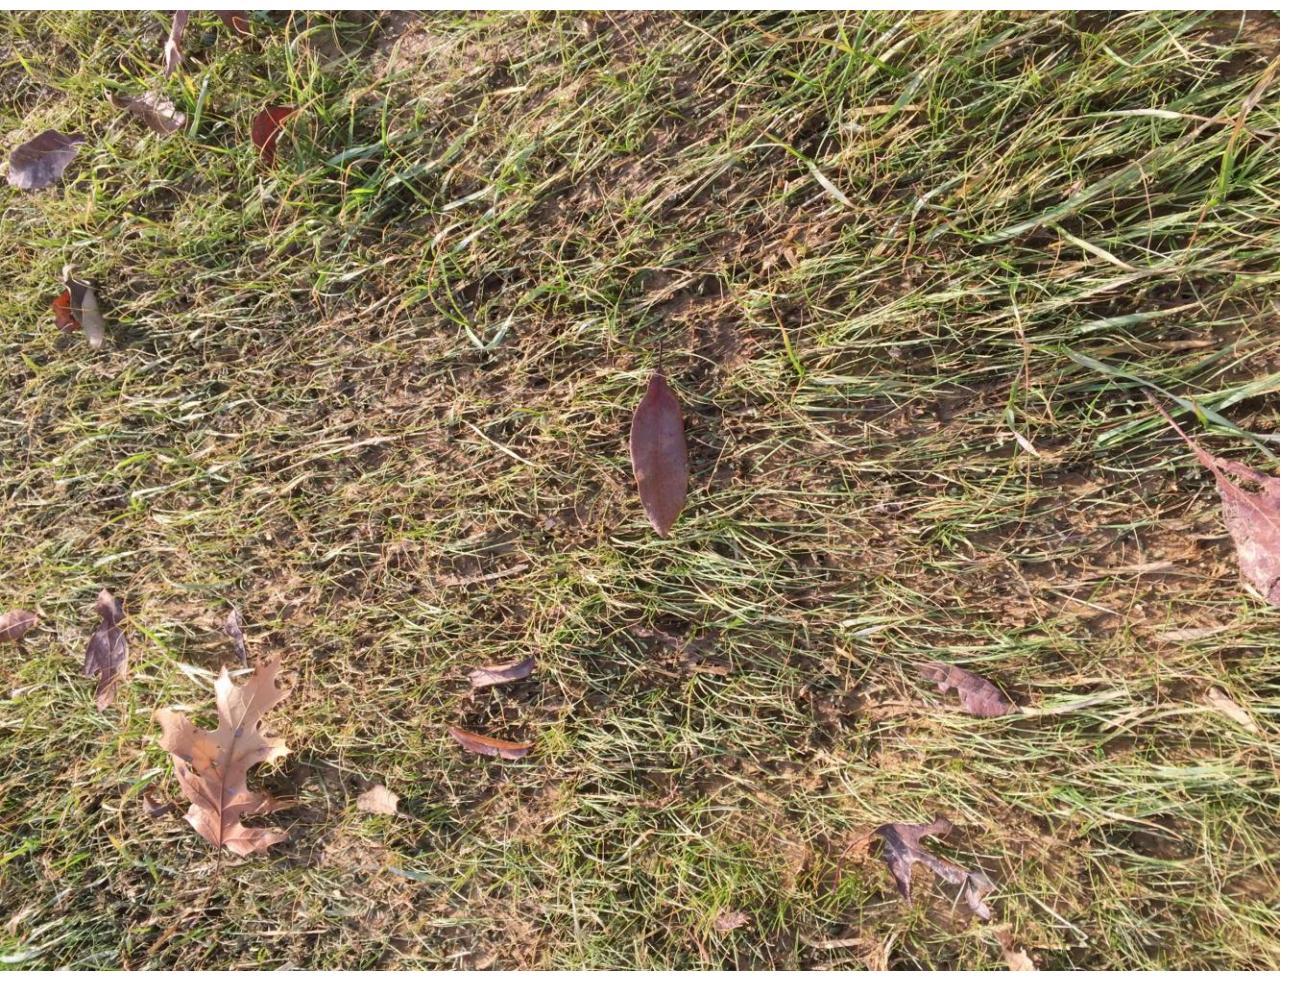
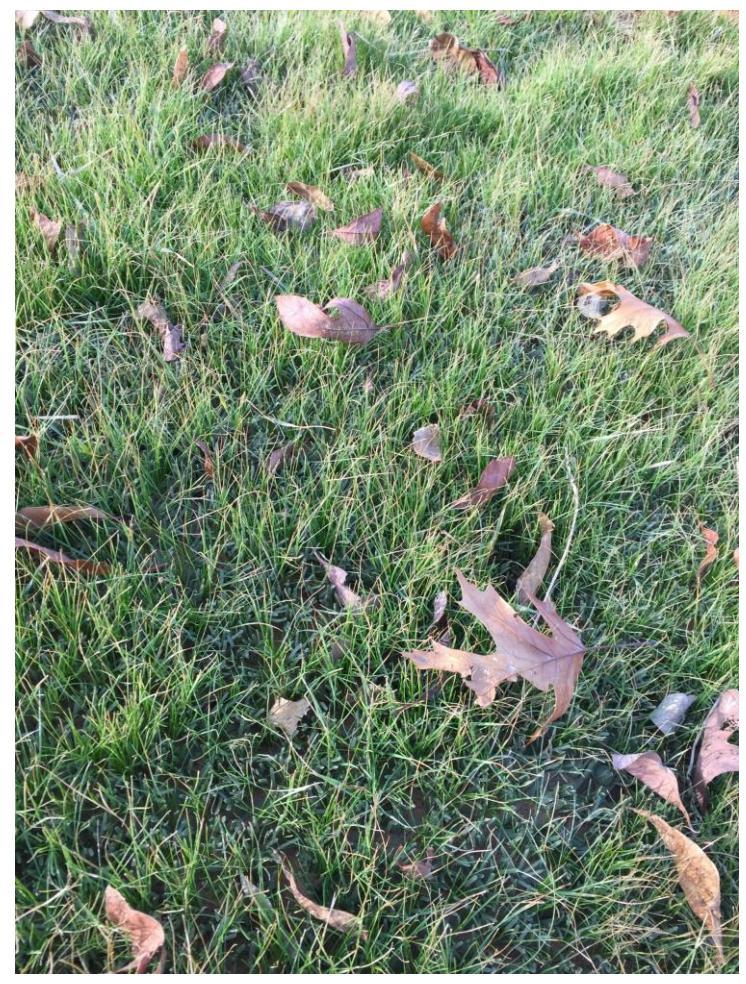
New grass growing on channel bed (left) appeared to be in good condition in spite of being laid over by water flow. Grass on the left sideslope (right) was quite dense, especially compared to surrounding straw-mulched areas.

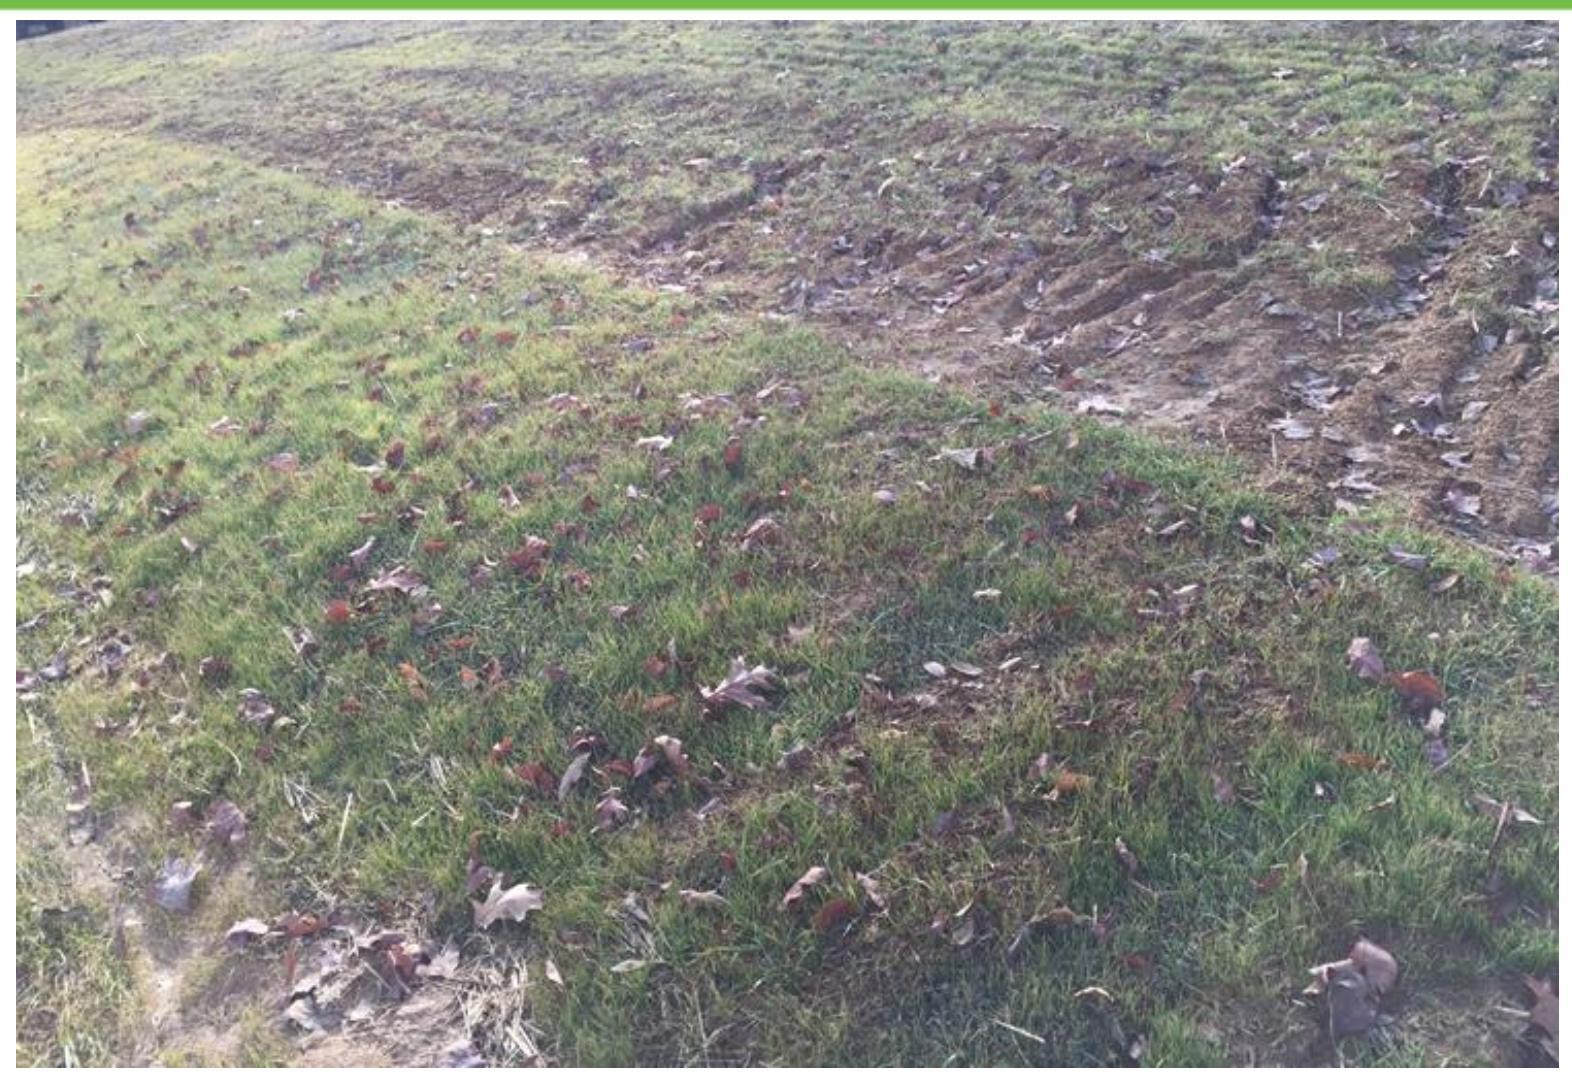
# ShearForce10 on Left Sideslope

The staple anchor check at top edge of left sideslope effectively prevented rills in unprotected upslope area from undermining the ShearForce10.

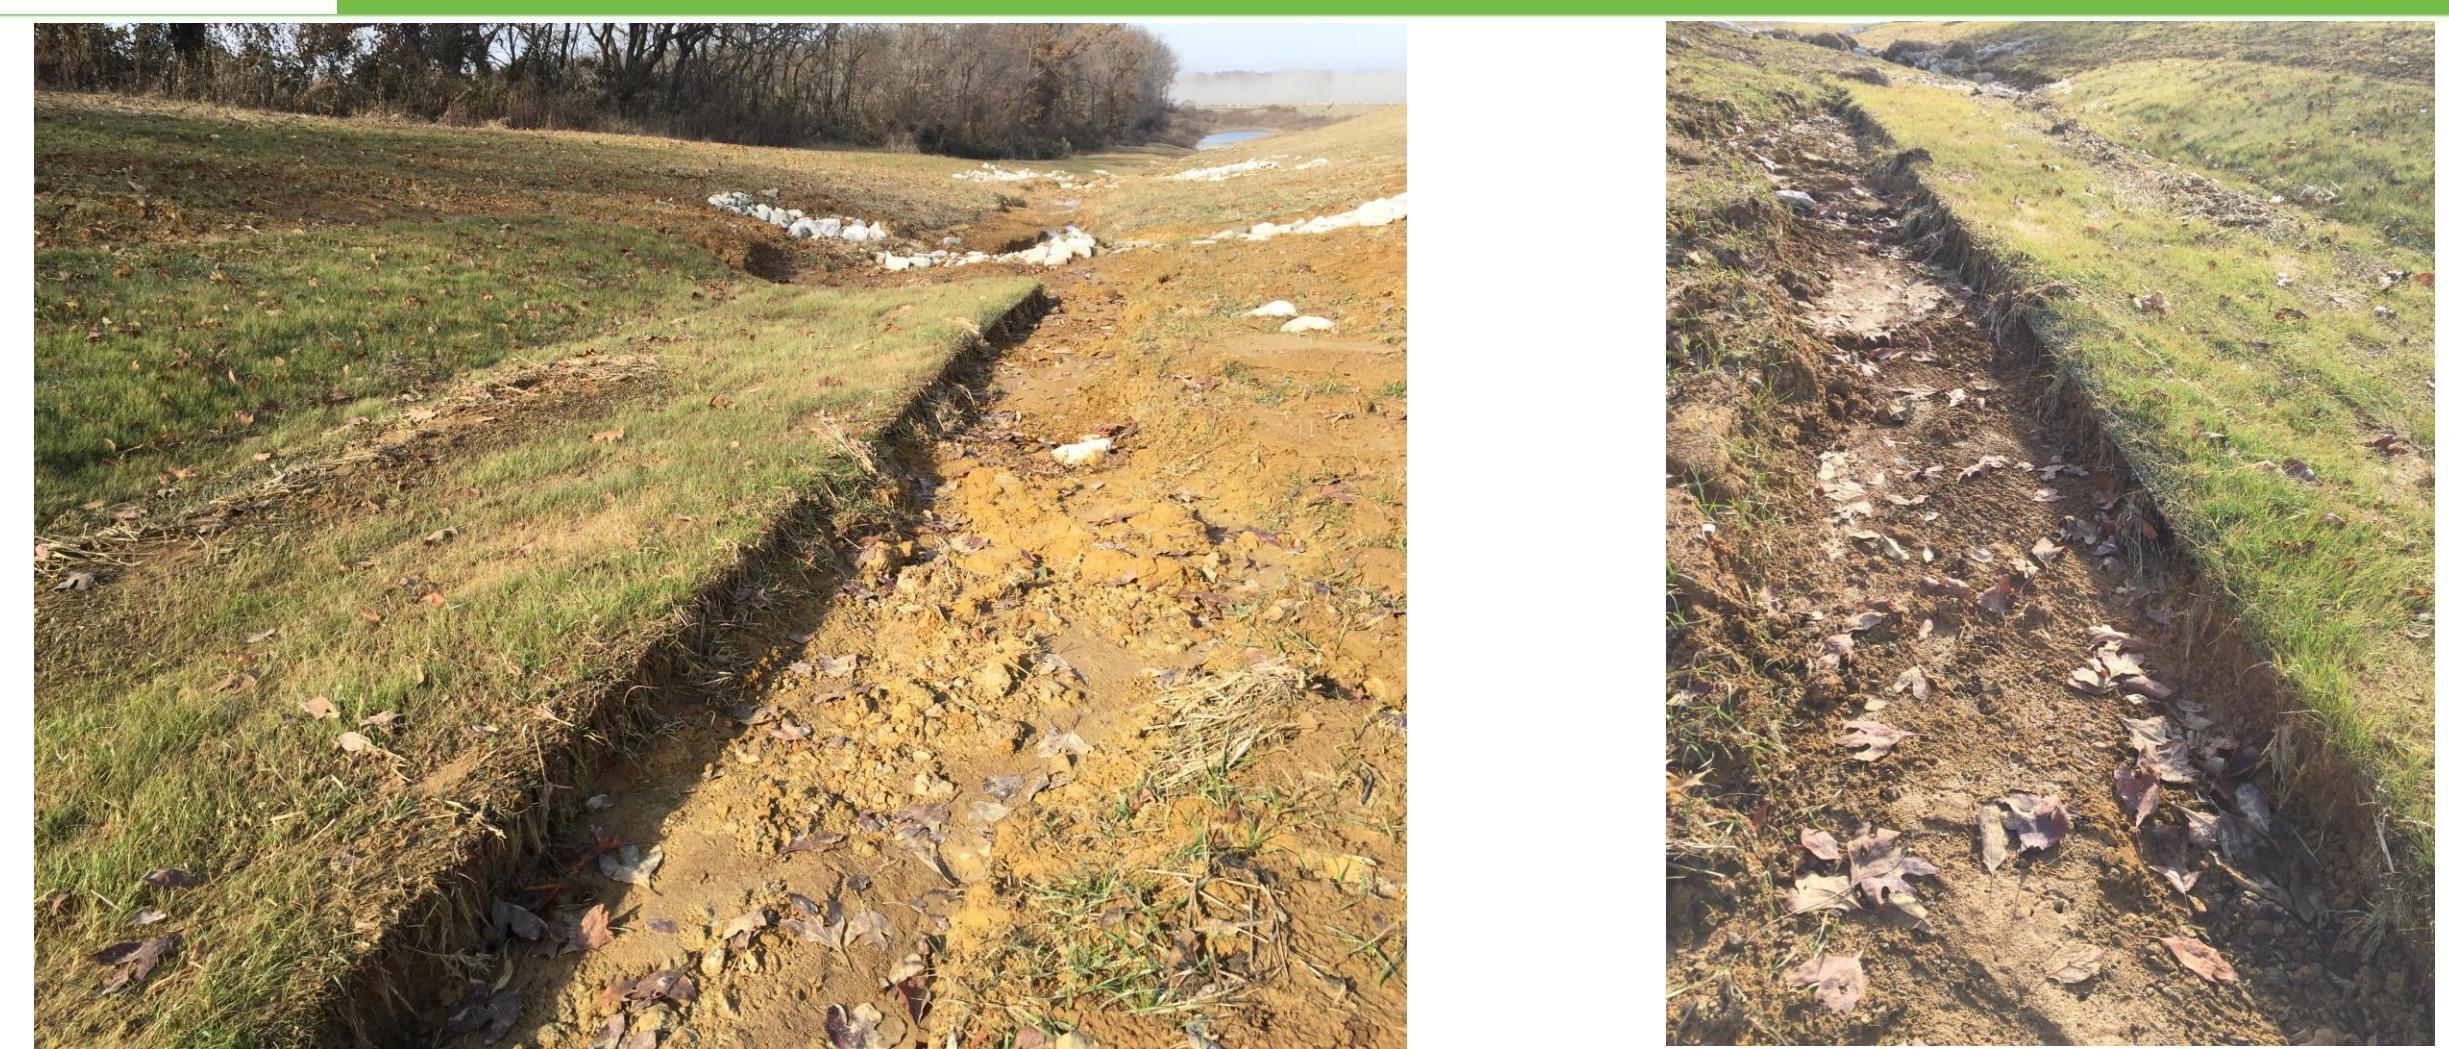
#### The Consequences of Underestimating Flow Depth

But wait, there's more. Apparently we should've used more ShearForce10! The right sideslope (looking downstream) where no ShearForce10 was used was badly scoured by over 8 inches. Incredibly, the ShearForce10 prevented erosion of soils and vegetation directly under it. Never seen anything like this before!
