# Peabody Coal – InstaTurf ShearForce10 ECTRM Trial Channel Installation

ShearForce10 ECTRM Installed over cool season grass mix in high flow channel at the base of an overburden cap on September 10, 2019. Objective: Evaluate potential as rock riprap replacement in high flow areas at the mine

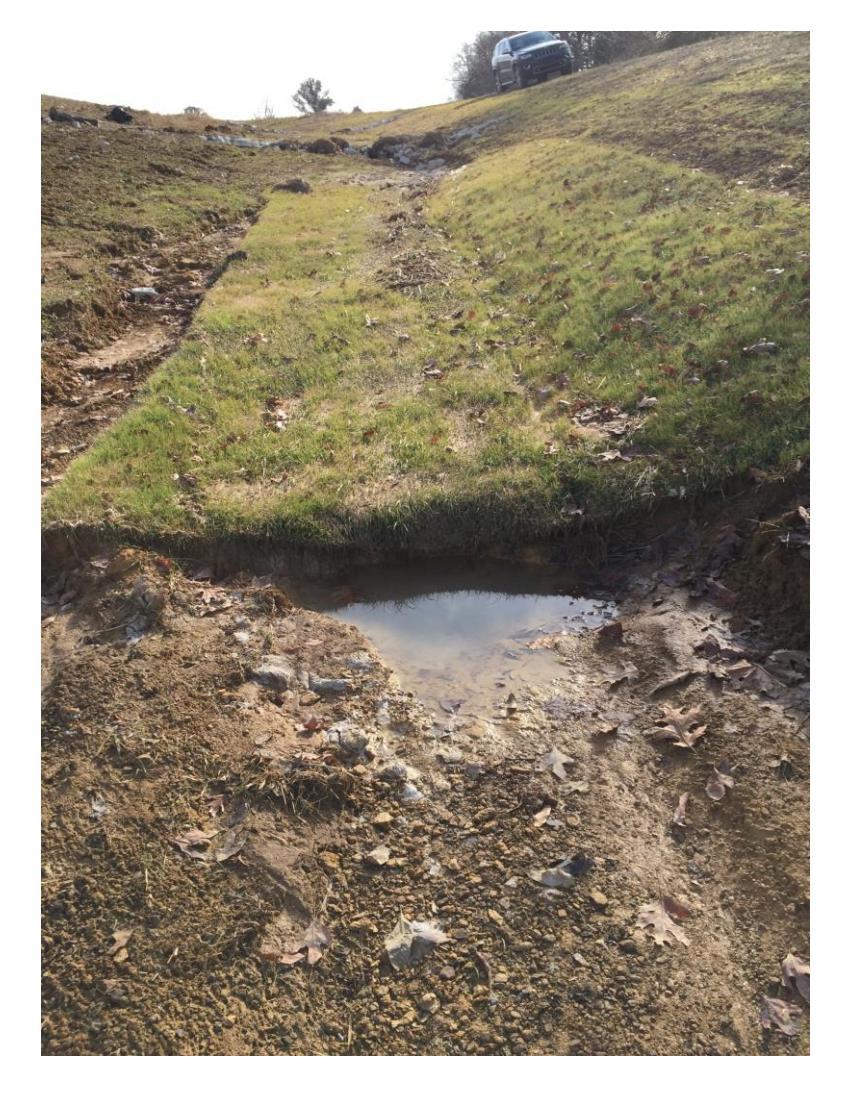
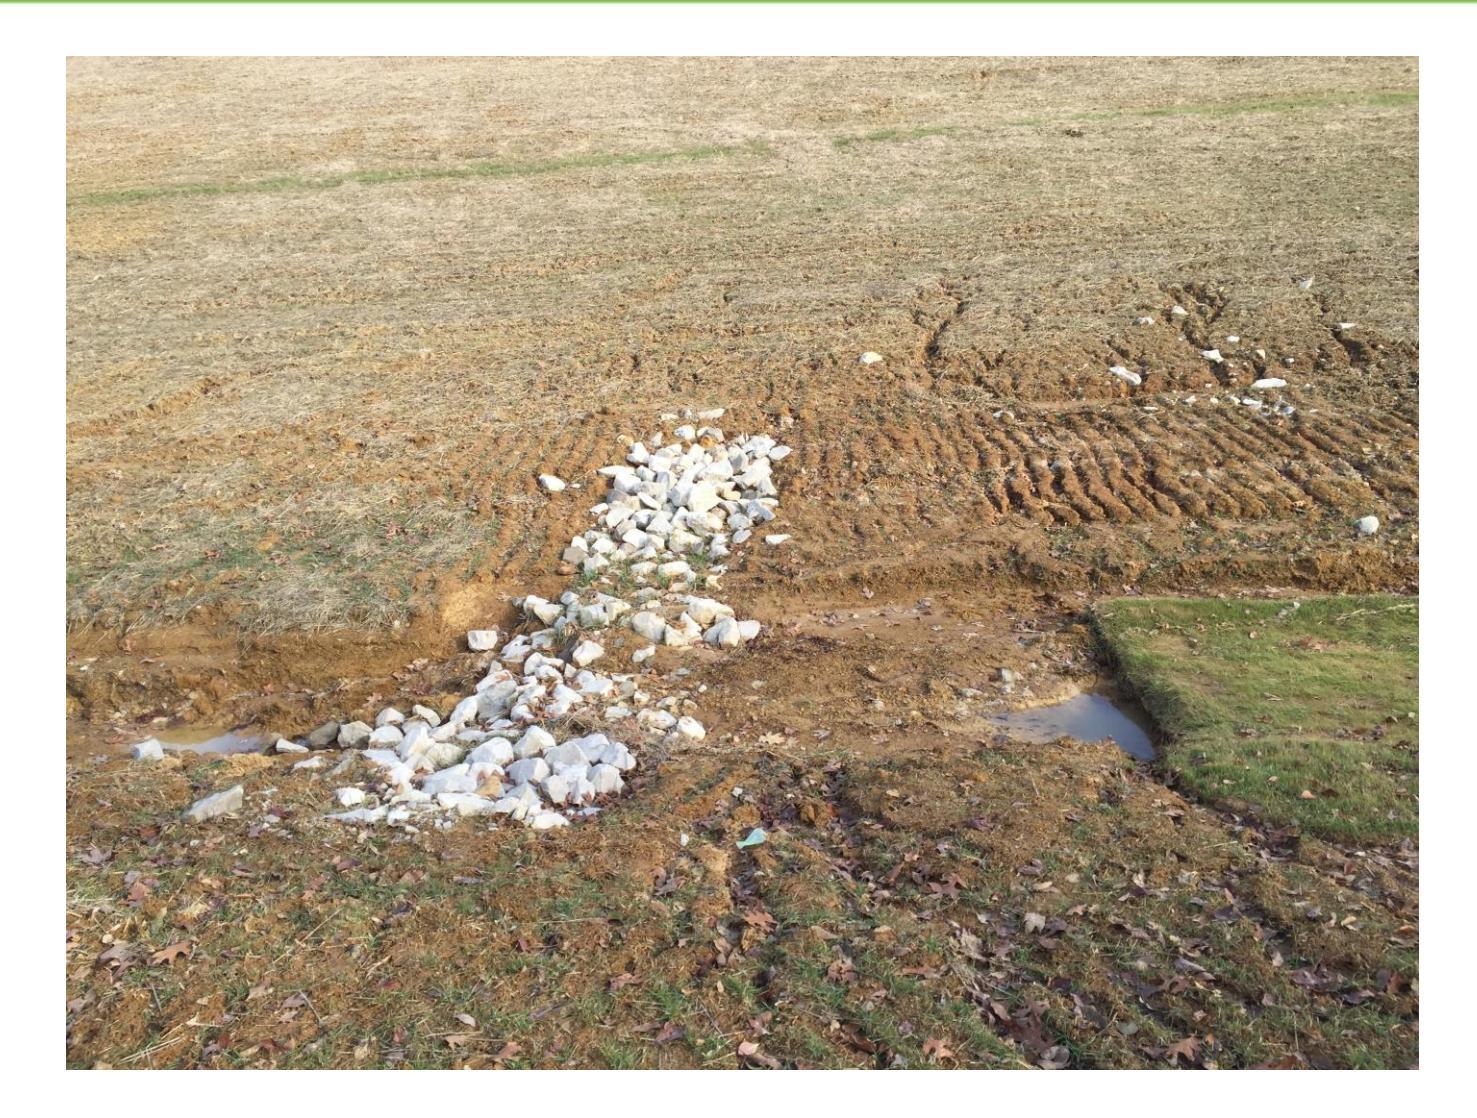
The unprotected area downstream from the ShearForce10 exhibited severe scour over 12 inches deep!

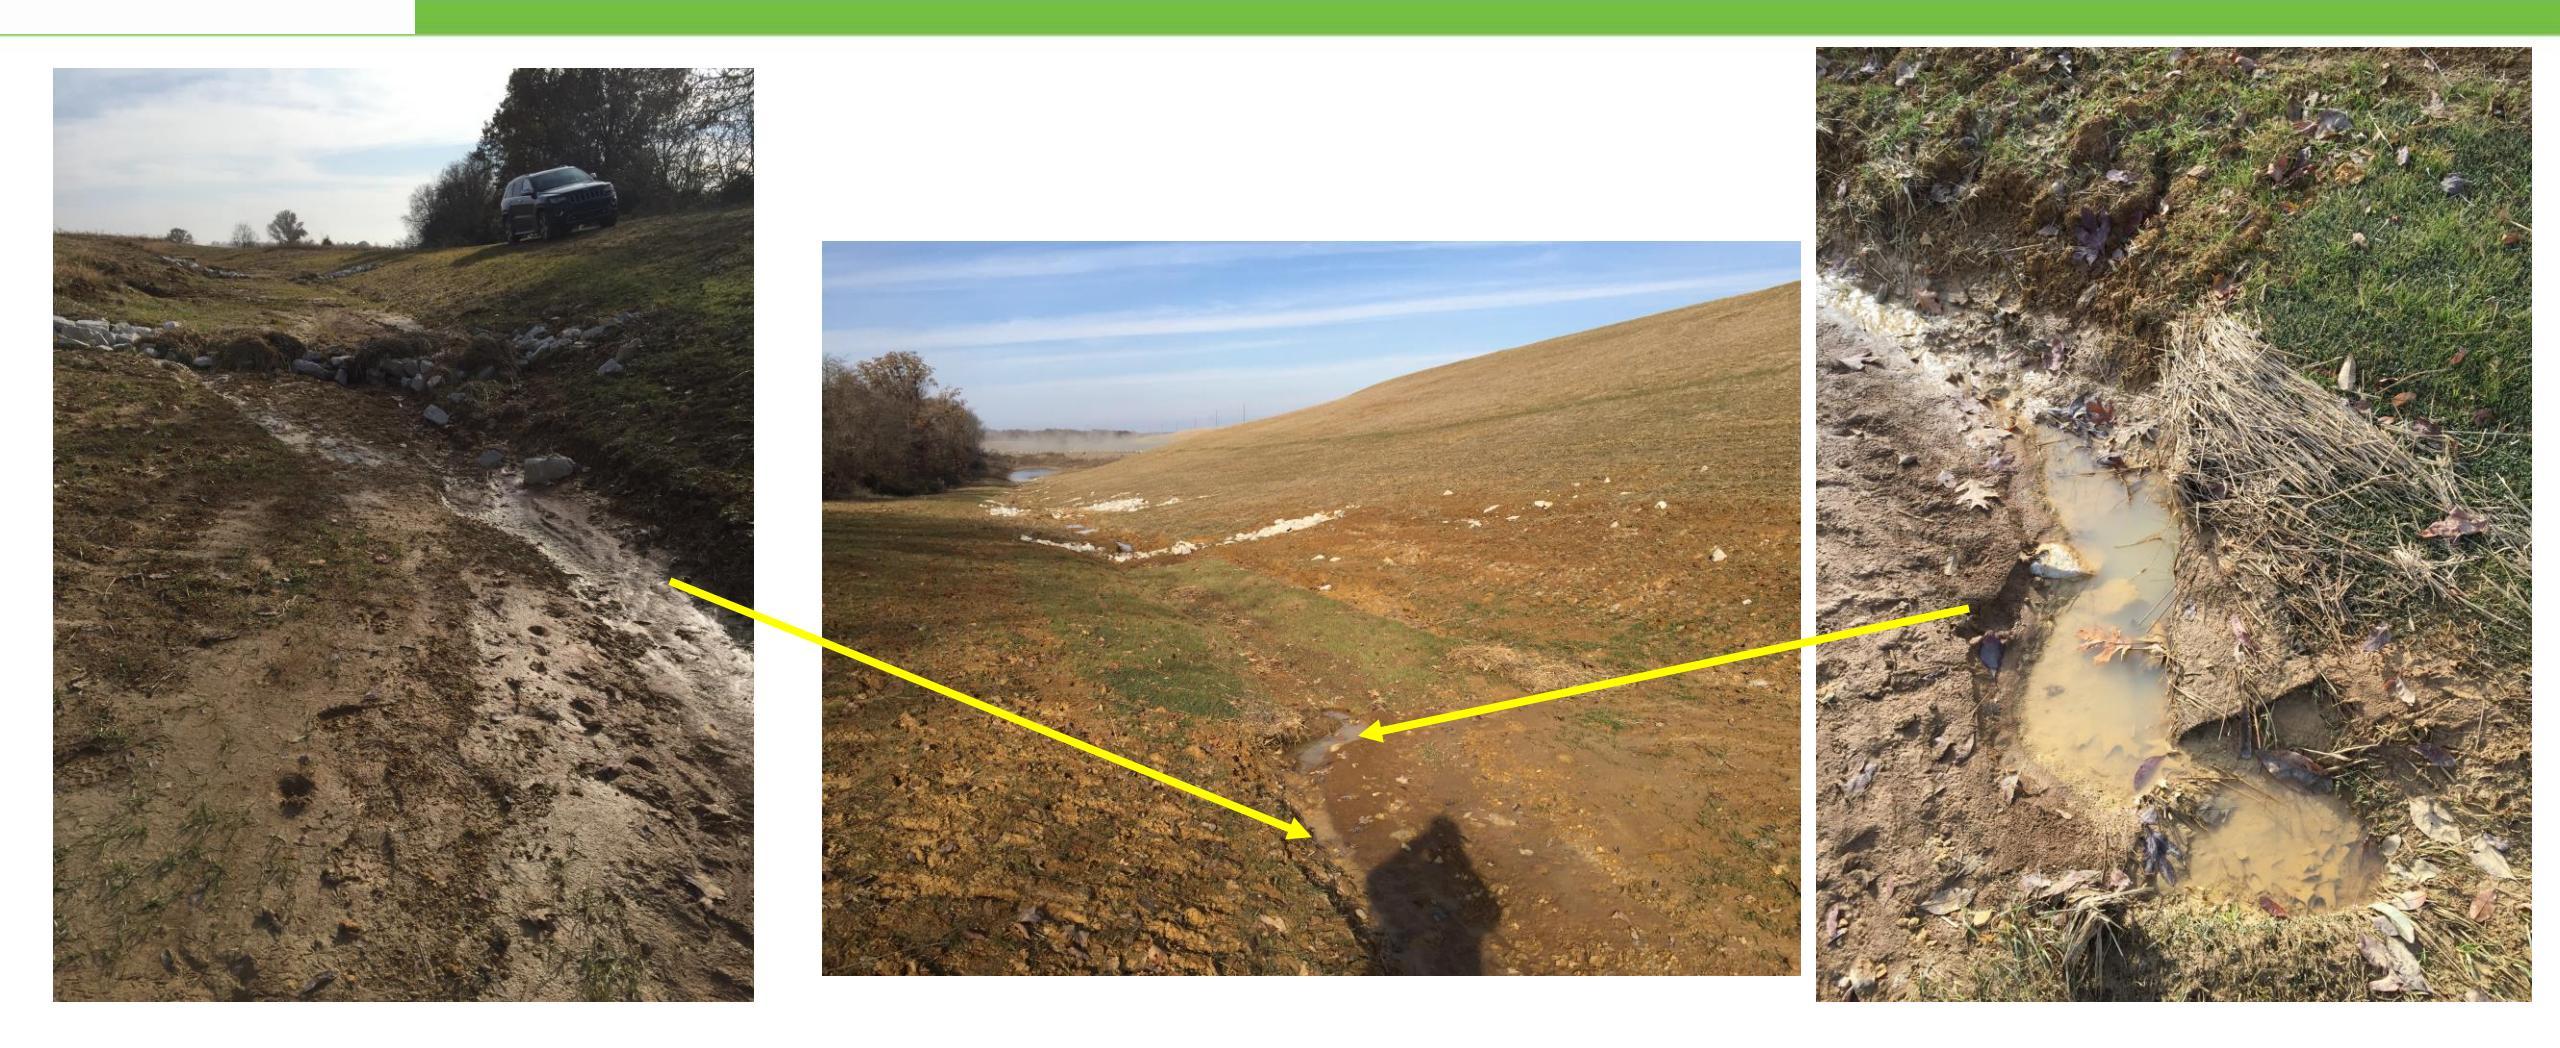
# Scour of Unprotected Upstream "Control" Section

The only mat "breach" observed was at the upstream terminal end. Scour from the upstream unprotected area encroached the 6 inch trench and flipped back the edge of one mat. Remarkably the ShearForce10 prevented undermining from progressing more than 1ft. Note: In retrospect, we should've installed mat up to and under the rock check dam.

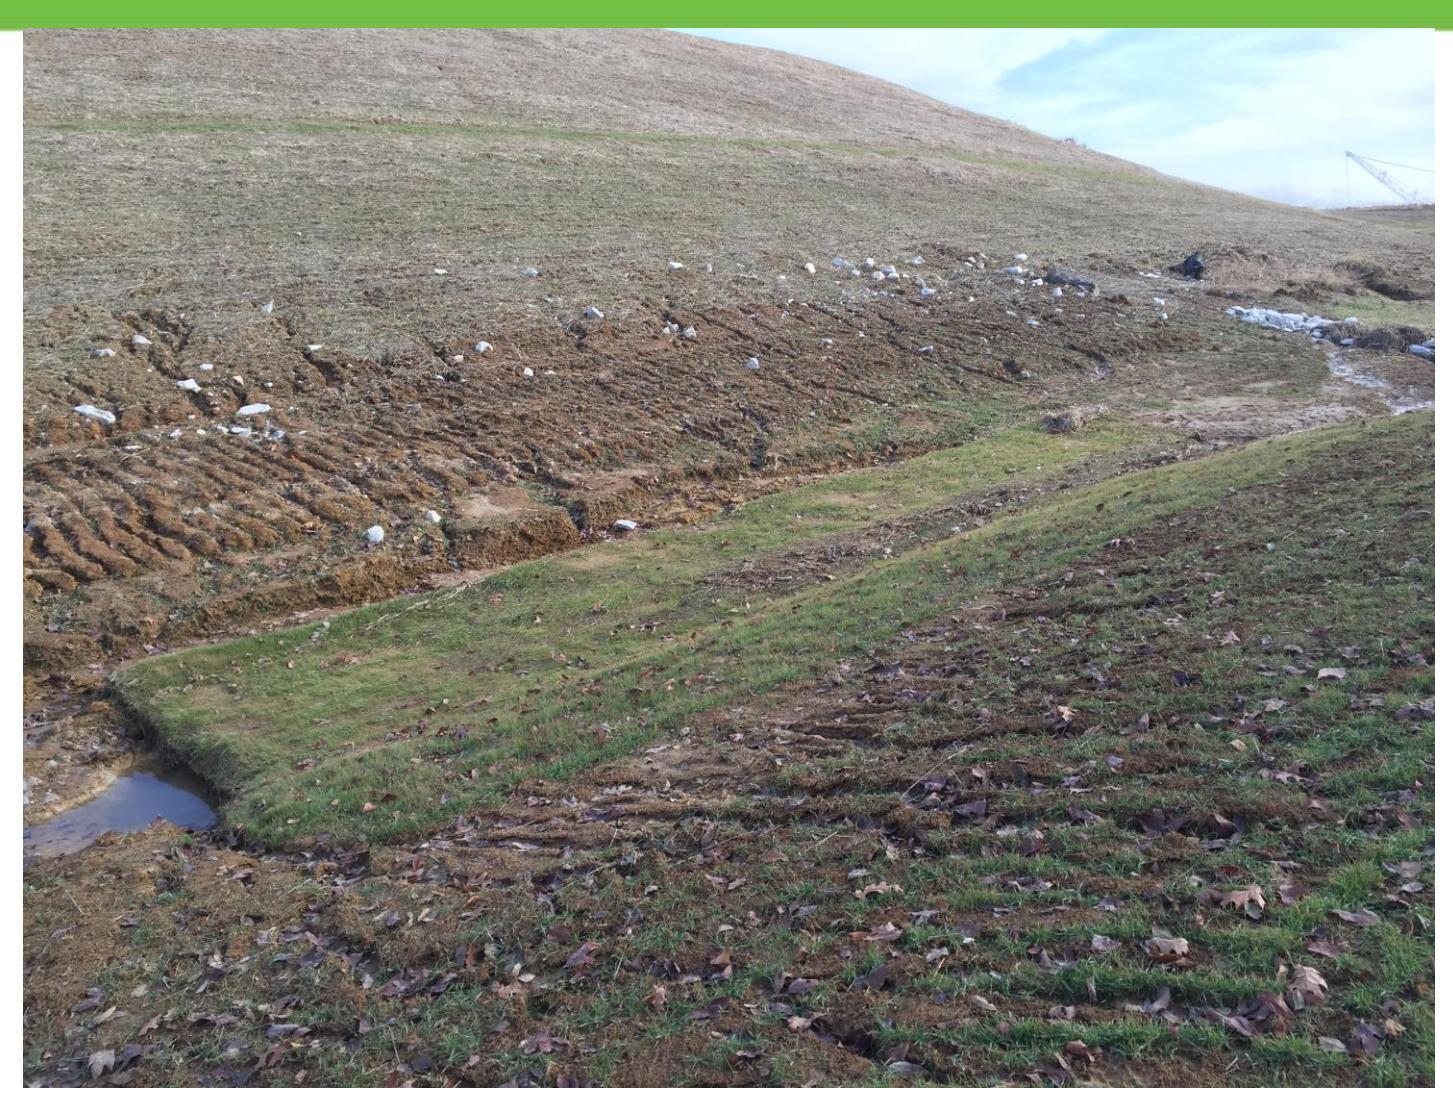
### Lesson Learned – USE MORE INSTATURF!

As illustrated by the severe erosion and scour of adjacent unprotected soils , the ShearForce10 performed incredibly well at locking down soils, while growing and reinforcing natural grass under extreme conditions!
