SUBSTATION STABILIZATION

EASTERN VIRGINIA

INITIAL CONCERN

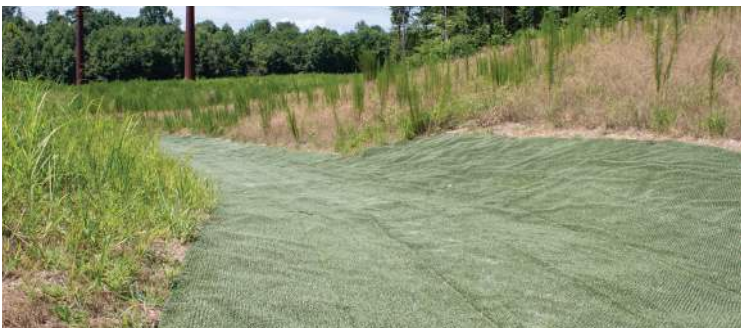
Before hurricane—outfall channel.

All three applications were outfitted with ShearForce 10. The installation process was simple with the ground ALREADY prepared and seeded prior to the installation of the mats. When the prep work was complete, the mats were simply unrolled and pinned into place with anchor trenches dug upstream to prevent uprooting of the matting. 12-in pins with washers were used to anchor the mats down, and 6-in U staples were used to hold the mats together along the seams.

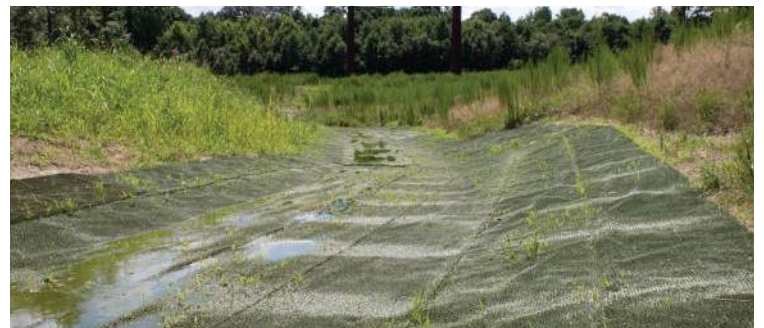
After hurricane—outfall channel.

While the owner was thrilled with the results following installation, the installation and term “immediate protection” was put to the test almost 2 weeks later when Hurricane Isaias came through, dumping 6" of rainfall on the site with wind gusts of 50+ mph. This storm would have devastated the existing sod or a newly installed TRM. As the pictures above and on the back show, the newly installed ShearForce successfully protected all areas from erosion and was not affected by the storm. After experiencing this success, the owner is now installing this product on other sites as well.

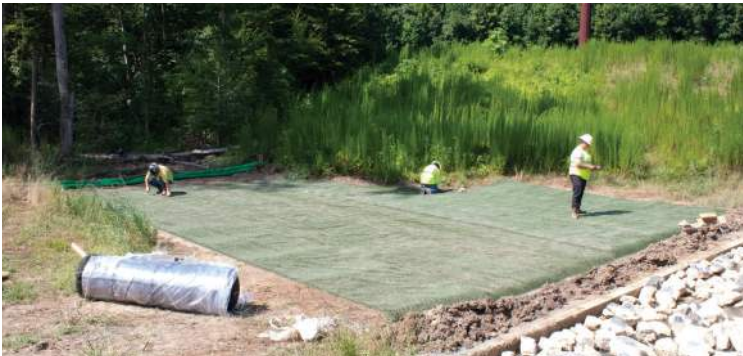
Before hurricane—emergency spillway.

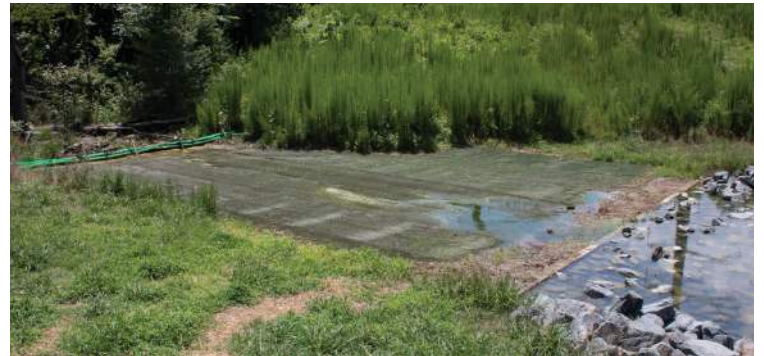
After hurricane—emergency spillway.

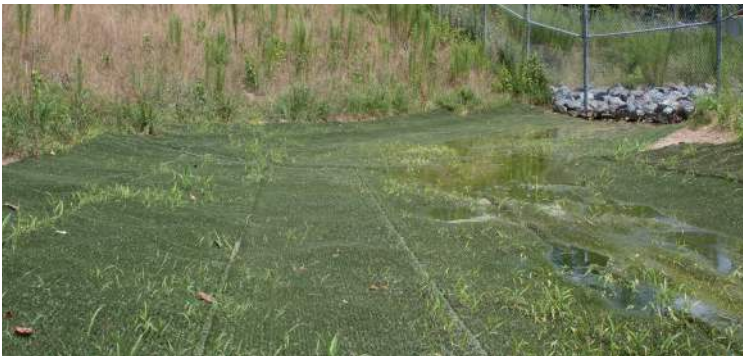
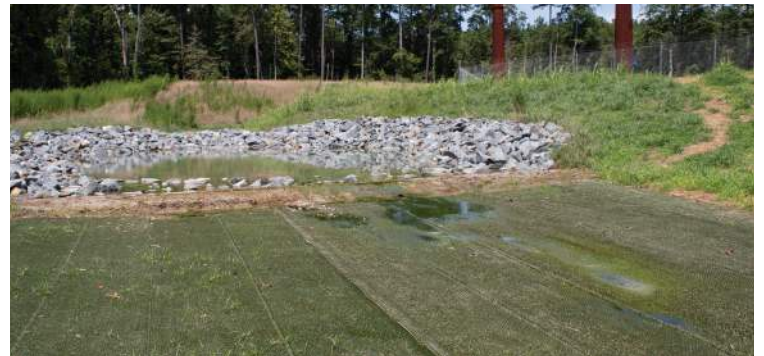
Additional photos after Hurricane Isaias.

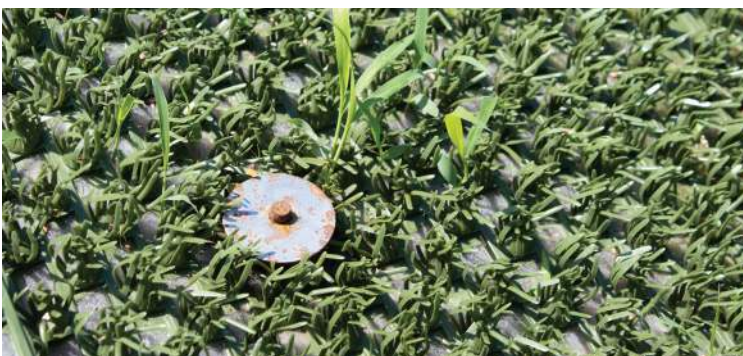
Anchored using pins and washers.

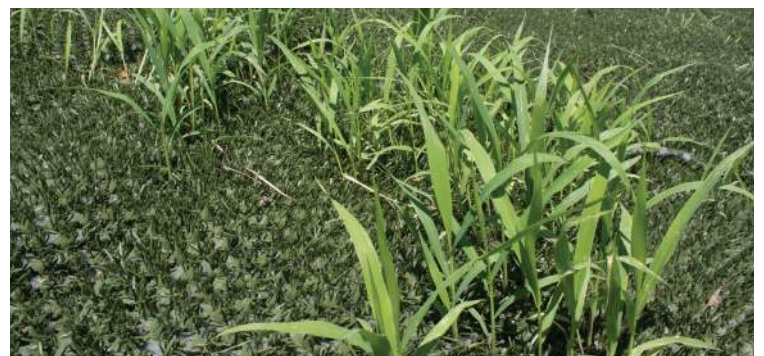
Vegetation growth 3 weeks after installation.
