SCOURLOK® RETENTION WALL

HORNELL, NY

INITIAL CONCERN

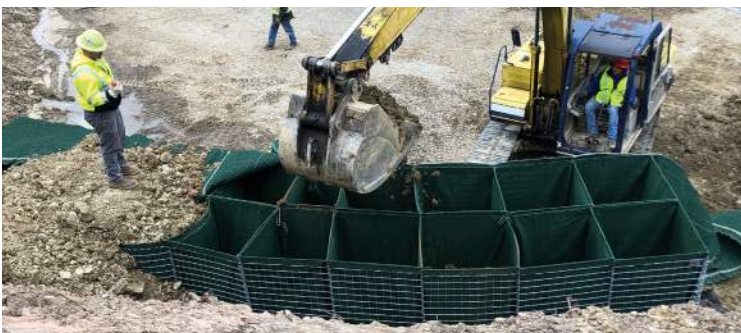
First layer of Scourlok being filled - 2 cells deep.

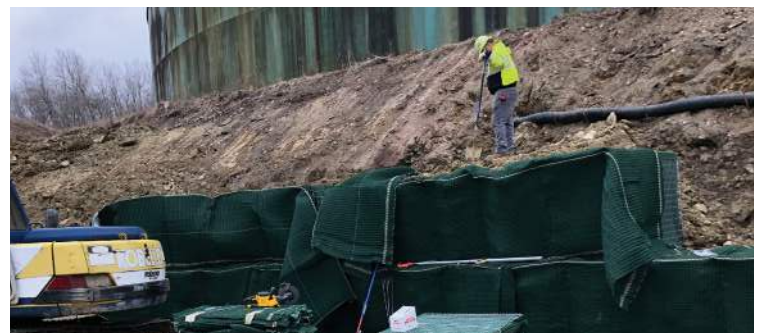
Second layer of Scourlok being covered with soil following being filled (1 cell deep).

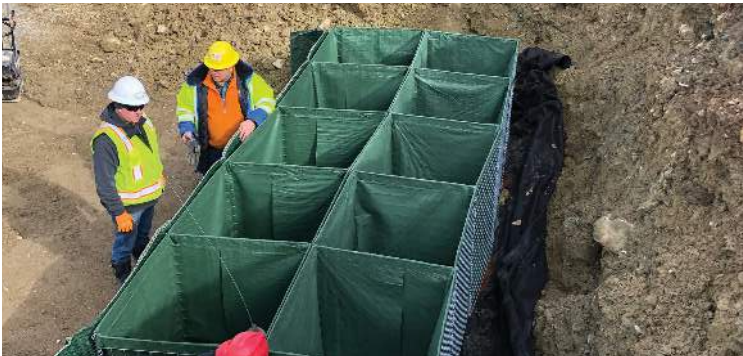
Connecting the cells for the first layer of Scourlok.

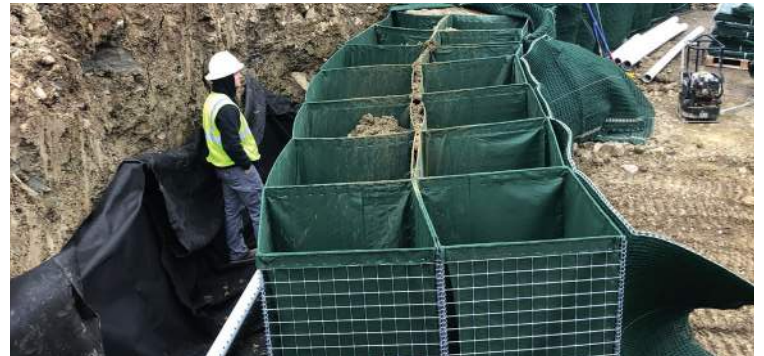
Scourlok flexibility to work with radial alignment.

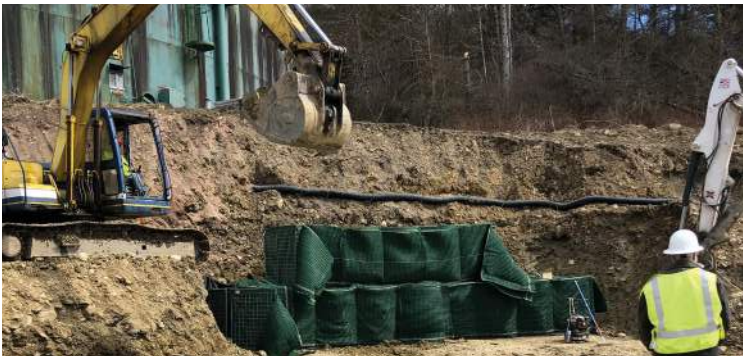
Machinery filling cells with on-site material.

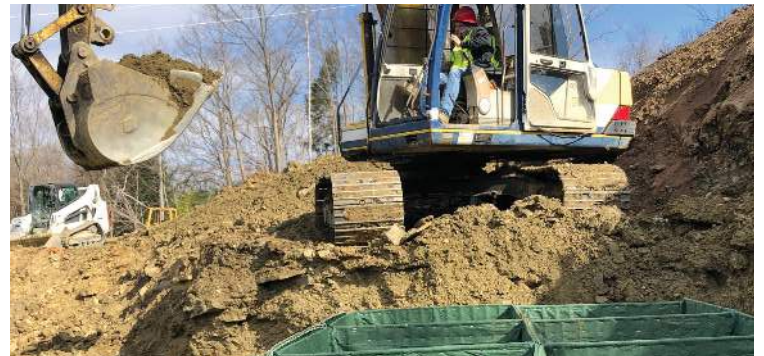
Limited space on site for installation.

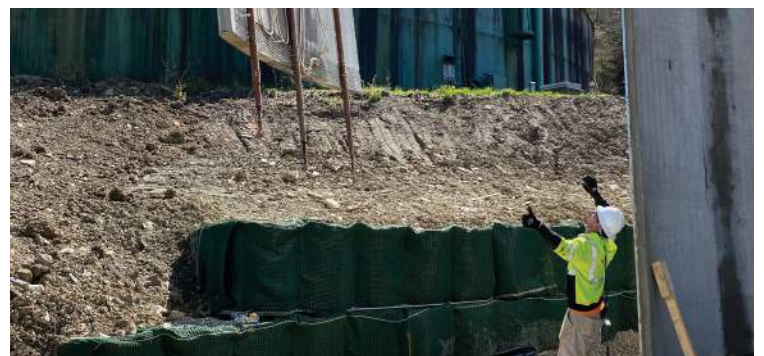
Placing of water tank panels near Scourlok face.
