NORTH POINT STATE PARK

BALTIMORE, MD

INITIAL CONCERN

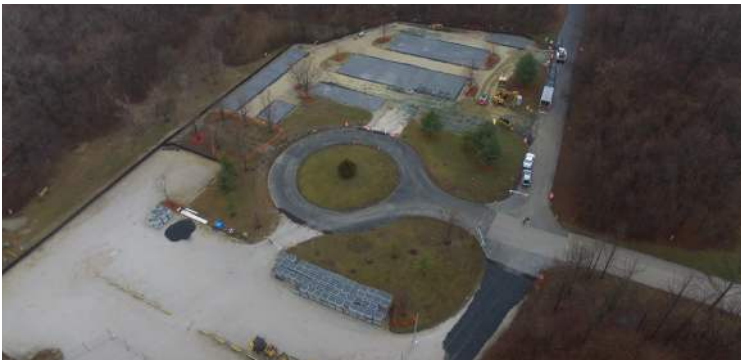
During installation

The installation included a layer of #2 stone for storage with a layer of #57 stone over it to assist with both filtration and storage. The layer of #7 or #8 stone that is often used for leveling pavers is not required with the PowerBLOCK system, which helps reduce the likelihood of clogging towards the top of the system. A combination of overdrains and underdrains were also installed to assist in removing water from the system during larger storms.

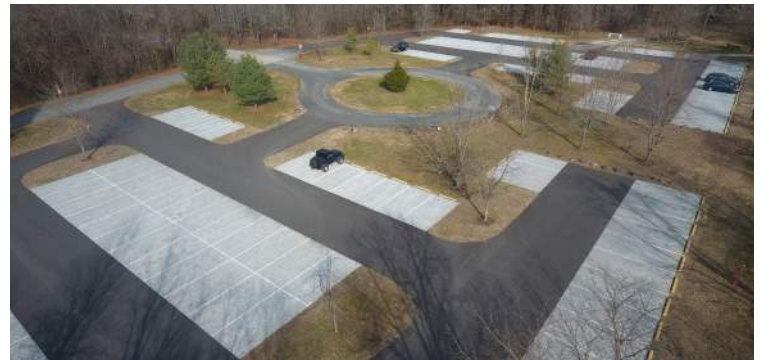
Post-installation

More than two years after installation, the permeable paving system is still operating as expected with little maintenance required. The leading edges are starting to show signs of clogging, but the water is able to flow past these edges to achieve the desired infiltration rates (1,000 in/hr). While the system doesn't usually require vacuuming for 5-10 years, we have recommended that it be vacuumed every 3 years to clear the leading edges before the compaction becomes extremely difficult for maintenance to remove. As the system uses open-joint pavers, the maintenance is limited to simple vacuuming and the joints will not need to be refilled with stone.

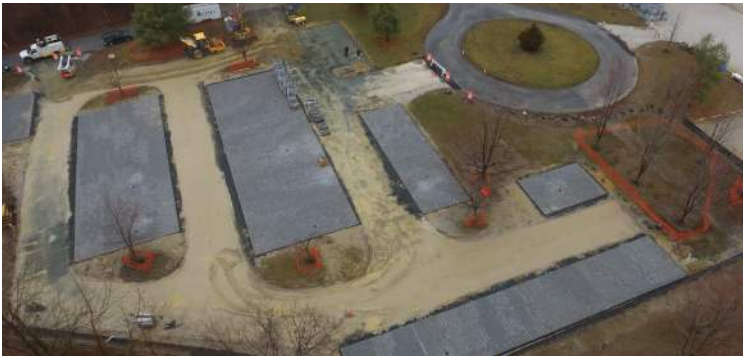
Parking lot under construction.

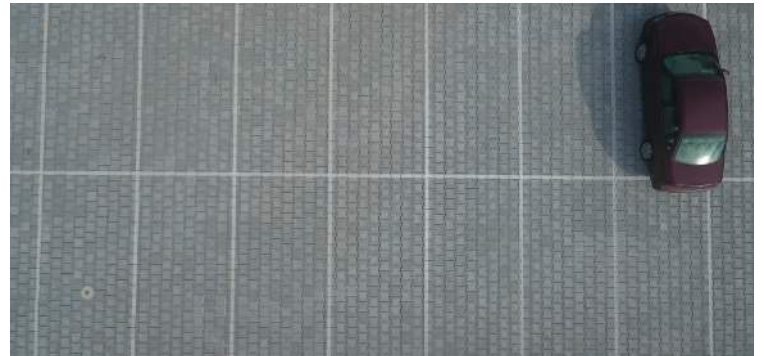
Section of PowerBLOCK parking lot.

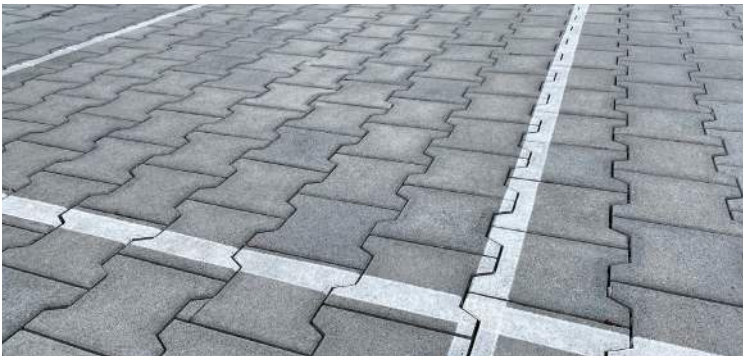
Painted lines on PowerBLOCK.

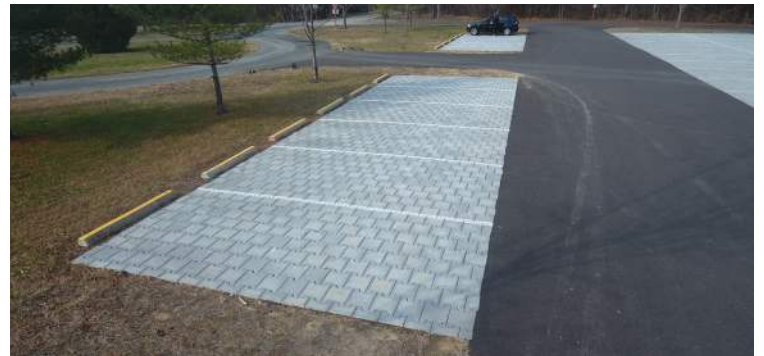
Asphalt drive aisle paired with PowerBLOCK.

After experiencing many issues with the gravel lot, the client was interested in using permeable pavers to create a more formal parking surface that would allow infiltration and reduce maintenance. As the lot was 1.7 acres, the engineer decided to use asphalt and pave the driving lanes at a pitch towards the parking spots that would feature PowerBLOCK open-joint permeable pavers (approximately 25,000 sf throughout the lot). While PowerBLOCK pavers are capable of providing the required load support to be utilized in drive lanes, the engineer was able to reduce costs while meeting all necessary regulations by only using the pavers in the 141 parking spots.

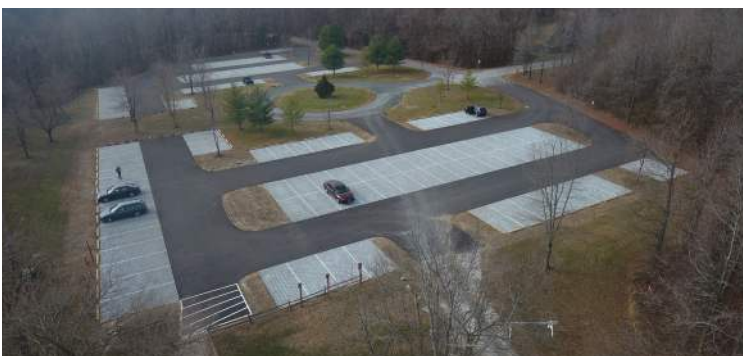
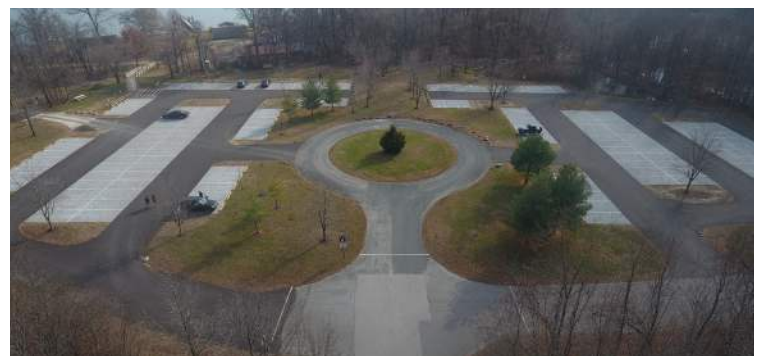
Aerial views of the completed PowerBLOCK installation.
