CASE STUDY

2781 Glen Garden Drive

Fort Worth, Texas

Concrete Canvas

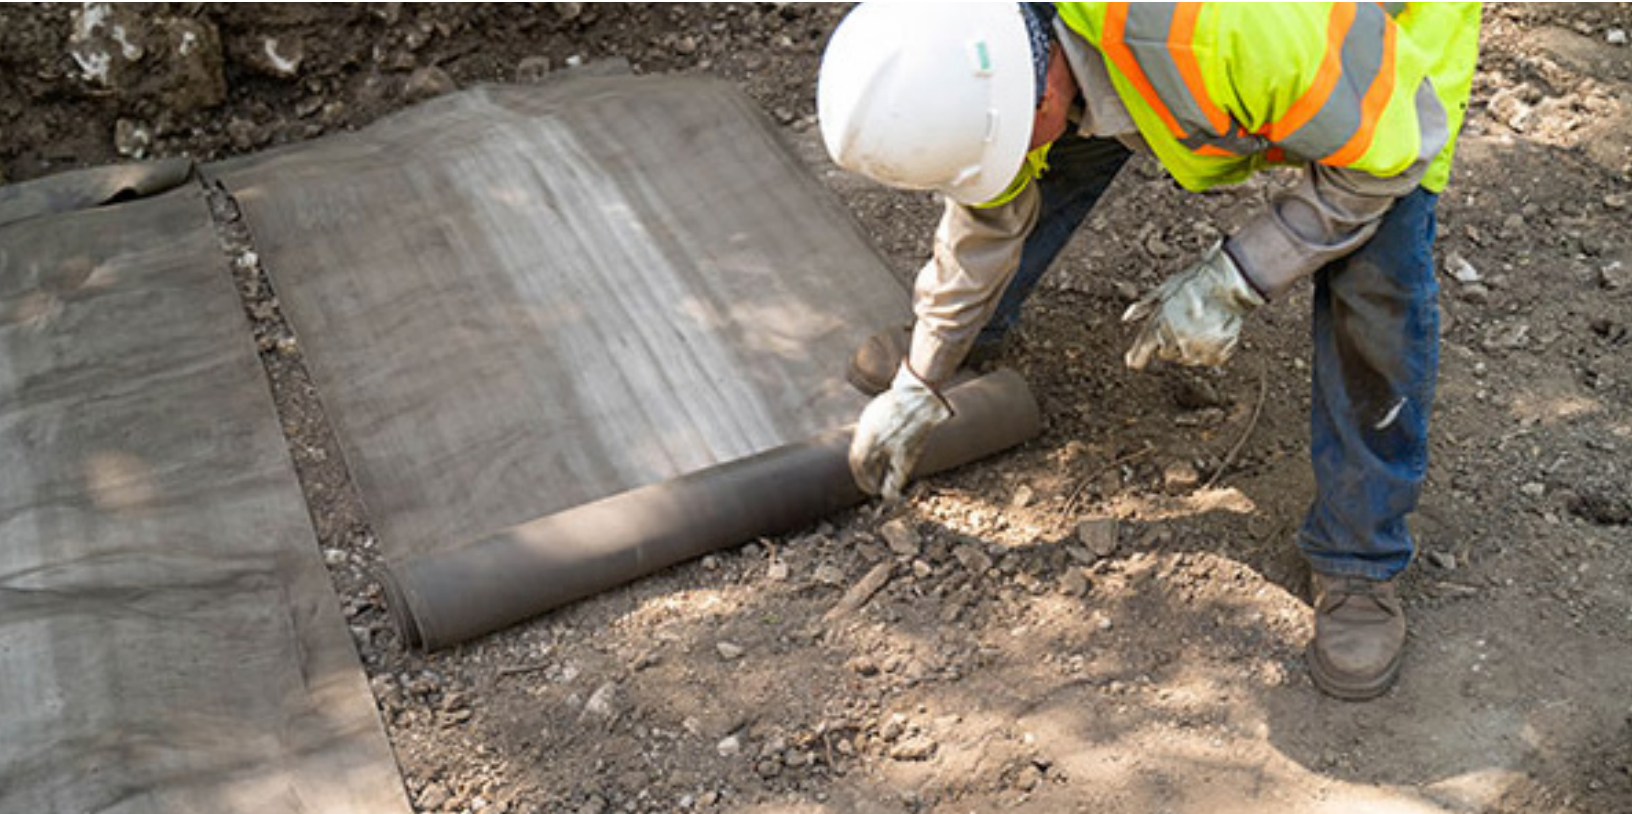
Between Ferguson, Concrete Canvas, and the City of Fort Worth, our installation crew overlapped pre-cut sections of Concrete Canvas down the channel in accordance to its flow direction, similar to applying shingles on a roof. The Concrete Canvas made intimate contact with the existing flume by use of Elephant Armor, a fiber-reinforced, quick-setting concrete, to provide successful termination of the system at its entry and exit points.

The side slopes were hydroseeded and protected with an erosion control blanket until adequate vegetation was achieved. After hydrating the Concrete Canvas and completing installation, the system passed several heavy water flow tests. The City of Fort Worth will be monitoring this project over the course of the next year. Their stormwater department hopes to implement Concrete Canvas as a standard solution for future City repair/maintenance projects.
